Access Compliance Report

Public Rights-of-Way

(Island Curb Cuts)

Intersection ID: 10034318	Main Street: PERIMETER_POINTE_PY	Cross Street: N/A	Location: E
ADA ID: 880828EB8F64	Curb Cut Type: MedianRefuge2	Initial Pass/Fail: Fail	Overall Compliance: No
Severity Score: 10			
Codes/Mitigation Info/Possible Solution		Field Measurements/Component Compliance

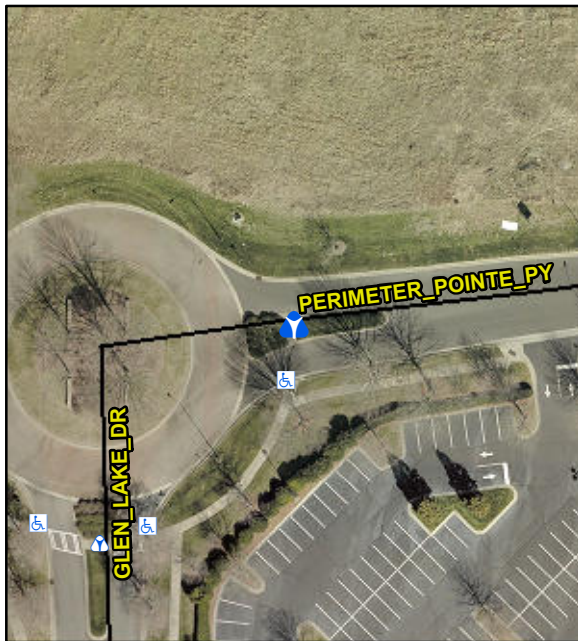
Compliance	Description	Data	Compliance	Description	Data
Yes	Refuge 1 Length (In)	77.5	N/A	Gutter 1 Ponding?	N/A
No	Refuge 1 Width (In)	59.0	N/A	Gutter 1 Lip Ht (In)	N/A
Yes	Refuge 1 Slope (%)	1.9	N/A	Gutter 1 Slope (%)	N/A
Yes	Refuge 1 X Slope (%)	2.2	N/A	Gutter 1 X Slope (%)	N/A
N/A	Painted X Walk1?	No	N/A	DWS 1 Provided?	N/A
N/A	X Walk 1 Direction	To S	N/A	DWS 1 Contrast?	N/A
N/A	X Walk 1 Width (In)	N/A	N/A	DWS 1 Length (In)	N/A
N/A	Road 1 Slope (%)	2.0	N/A	DWS 1 Full Width?	N/A
N/A	Road 1 X Slope (%)	2.2	N/A	DWS 1 Offset (In)	N/A
Yes	Refuge 2 Length (In)	77.5	N/A	Gutter 2 Ponding?	N/A
No	Refuge 2 Width (In)	59.0	N/A	Gutter 2 Lip Ht (In)	N/A
Yes	Refuge 2 Slope (%)	2.9	N/A	Gutter 2 Slope (%)	N/A
Yes	Refuge 2 X Slope (%)	0.9	N/A	Gutter 2 X Slope (%)	N/A
N/A	Painted X Walk2?	No	N/A	DWS 2 Provided?	N/A
N/A	X Walk 2 Direction	To N	N/A	DWS 2 Contrast?	N/A
N/A	X Walk 2 Width (In)	N/A	N/A	DWS 2 Length (In)	N/A

Remove & Replace Entire Refuge.
