Access Compliance Report

Public Rights-of-Way

(Island Curb Cuts)

Intersection ID: 18026	Main Street: E_INDEPENDENCE_BV	Cross Street: WALLACE_LN	Location: W
ADA ID: 892596C372F6	Curb Cut Type: MedianRefuge2	Initial Pass/Fail: Pass	Overall Compliance: No
Codes/Mitigation Info/Possible Solution		Field Measurements/Component Compliance	
Severity Score: 15

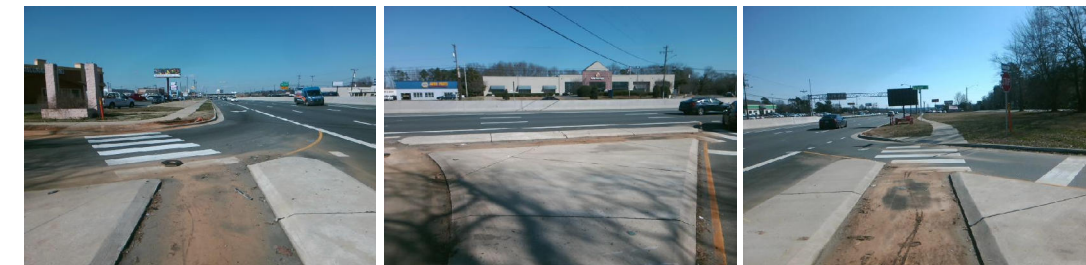
Compliance	Description	Data	Compliance	Description	Data
Yes	Refuge 1 Length (In)	183.0	Yes	Gutter 1 Ponding?	No
Yes	Refuge 1 Width (In)	71.0	Yes	Gutter 1 Lip Ht (In)	0.0
Yes	Refuge 1 Slope (%)	0.2	Yes	Gutter 1 Slope (%)	1.3
Yes	Refuge 1 X Slope (%)	1.6	Yes	Gutter 1 X Slope (%)	0.4
N/A	Painted X Walk1?	Yes	No	DWS 1 Provided?	No
N/A	X Walk 1 Direction	To NW	N/A	DWS 1 Contrast?	N/A
N/A	X Walk 1 Width (In)	122.0	N/A	DWS 1 Length (In)	N/A
N/A	Road 1 Slope (%)	0.8	N/A	DWS 1 Full Width?	N/A
N/A	Road 1 X Slope (%)	1.1	N/A	DWS 1 Offset (In)	N/A
Yes	Refuge 2 Length (In)	183.0	Yes	Gutter 2 Ponding?	No
Yes	Refuge 2 Width (In)	71.0	Yes	Gutter 2 Lip Ht (In)	0.0
Yes	Refuge 2 Slope (%)	0.6	Yes	Gutter 2 Slope (%)	0.9
Yes	Refuge 2 X Slope (%)	0.0	Yes	Gutter 2 X Slope (%)	0.7
N/A	Painted X Walk2?	Yes	No	DWS 2 Provided?	No
N/A	X Walk 2 Direction	To SE	N/A	DWS 2 Contrast?	N/A
N/A	X Walk 2 Width (In)	96.0	N/A	DWS 2 Length (In)	N/A

N/A	Road 2 Slope (%)	0.6	N/A	DWS 2 Full Width?	N/A
N/A	Road 2 X Slope (%)	1.2	N/A	DWS 2 Offset (In)	N/A
N/A	Refuge 3 Length (in)	N/A	N/A	Gutter 3 Ponding?	N/A
N/A	Refuge 3 Width (in)	N/A	N/A	Gutter 3 Lip Ht (in)	N/A
N/A	Refuge 3 Slope (%)	N/A	N/A	Gutter 3 Slope (%)	N/A
N/A	Refuge 3 XSlope (%)	N/A	N/A	Gutter 3 XSlope (%)	N/A
N/A	Painted X Walk3?	N/A	N/A	DWS 3 Provided?	N/A
N/A	X Walk 3 Direction	N/A	N/A	DWS 3 Contrast?	N/A
N/A	X Walk 3 Width (in)	N/A	N/A	DWS 3 Length (in)	N/A
N/A	Road 3 Slope (%)	N/A	N/A	DWS 3 Full Width?	N/A
N/A	Road 3 XSlope (%)	N/A	N/A	DWS 3 Offset (in)	N/A
Yes	Any Obstructions?	N/A	N/A	Storm Grate/Utility Hazard?	No
N/A	Obstruction Type		N/A	Storm Grate/Utility Type	
		N/A			N/A
N/A	Surface Condition	Good

Install Detectable Warning System.
