Access Compliance Report

Public Rights-of-Way

(Island Curb Cuts)

Intersection ID: 7486	Main Street: N_TRYON_ST	Cross Street: OWEN_BV	Location:	N
ADA ID: 8A771A06A96A	Curb Cut Type: MedianRefuge2	Initial Pass/Fail: Pass	Overall Compliance: No	Severity Score: 0
Codes/Mitigation Info/Possible Solution		Field Measurements/Component Compliance

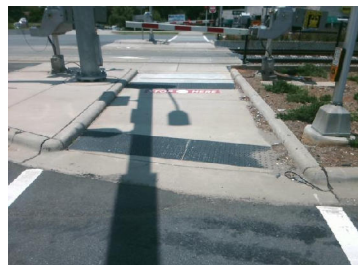
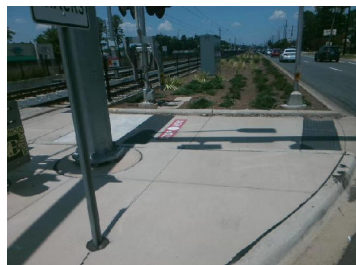
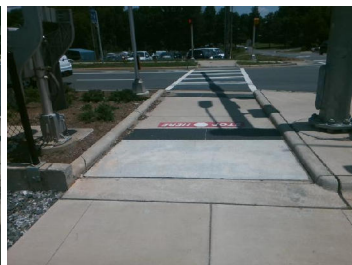
Compliance	Description	Data	Compliance	Description	Data
Yes	Refuge 1 Length (In)	105.0	Yes	Gutter 1 Ponding?	No
Yes	Refuge 1 Width (In)	107.0	Yes	Gutter 1 Lip Ht (In)	0.0
Yes	Refuge 1 Slope (%)	0.8	Yes	Gutter 1 Slope (%)	2.1
Yes	Refuge 1 X Slope (%)	0.6	Yes	Gutter 1 X Slope (%)	0.5
N/A	Painted X Walk1?	Yes	Yes	DWS 1 Provided?	Yes
N/A	X Walk 1 Direction	To E	Yes	DWS 1 Contrast?	Yes
N/A	X Walk 1 Width (In)	105.0	Yes	DWS 1 Length (In)	24.0
N/A	Road 1 Slope (%)	0.4	Yes	DWS 1 Full Width?	Yes
N/A	Road 1 X Slope (%)	2.6	No	DWS 1 Offset (In)	4.5
Yes	Refuge 2 Length (In)	105.0	Yes	Gutter 2 Ponding?	No
Yes	Refuge 2 Width (In)	107.0	No	Gutter 2 Lip Ht (In)	0.2
Yes	Refuge 2 Slope (%)	0.8	Yes	Gutter 2 Slope (%)	2.4
Yes	Refuge 2 X Slope (%)	0.2	Yes	Gutter 2 X Slope (%)	0.4
N/A	Painted X Walk2?	No	Yes	DWS 2 Provided?	Yes
N/A	X Walk 2 Direction	To W	Yes	DWS 2 Contrast?	Yes
N/A	X Walk 2 Width (In)	N/A	Yes	DWS 2 Length (In)	24.0

N/A	Road 2 Slope (%)	0.3	Yes	DWS 2 Full Width?	Yes
N/A	Road 2 X Slope (%)	0.5	No	DWS 2 Offset (In)	52.0
N/A	Refuge 3 Length (in)	N/A	N/A	Gutter 3 Ponding?	N/A
N/A	Refuge 3 Width (in)	N/A	N/A	Gutter 3 Lip Ht (in)	N/A
N/A	Refuge 3 Slope (%)	N/A	N/A	Gutter 3 Slope (%)	N/A
N/A	Refuge 3 XSlope (%)	N/A	N/A	Gutter 3 XSlope (%)	N/A
N/A	Painted X Walk3?	N/A	N/A	DWS 3 Provided?	N/A
N/A	X Walk 3 Direction	N/A	N/A	DWS 3 Contrast?	N/A
N/A	X Walk 3 Width (in)	N/A	N/A	DWS 3 Length (in)	N/A
N/A	Road 3 Slope (%)	N/A	N/A	DWS 3 Full Width?	N/A
N/A	Road 3 XSlope (%)	N/A	N/A	DWS 3 Offset (in)	N/A
Yes	Any Obstructions?	N/A	N/A	Storm Grate/Utility Hazard?	No
N/A	Obstruction Type		N/A	Storm Grate/Utility Type	
		N/A			N/A
N/A	Surface Condition	Good

Remove & Replace Detectable Warning System. Grind Gutter Lip.
