# Access Compliance Report

## Public Rights-of-Way

### (Island Curb Cuts)

Intersection ID: 11322	Main Street: N_GRAHAM_ST	Cross Street: W_10TH_ST	Location:	E
ADA ID: 8B029BD8673D	Curb Cut Type: IslandRefuge2	Initial Pass/Fail: Pass	Overall Compliance: No	Severity Score: 0

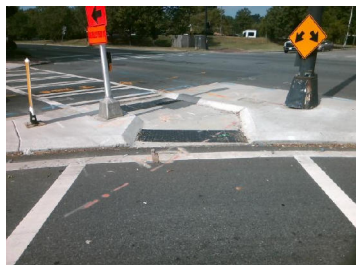
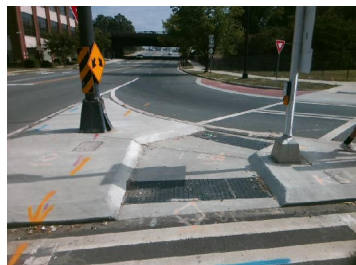
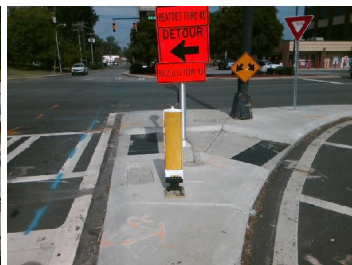
Compliance	Description	Data	Compliance	Description	Data
Yes	Refuge 1 Length (In)	53.0	Yes	Gutter 1 Ponding?	No
Yes	Refuge 1 Width (In)	73.0	Yes	Gutter 1 Lip Ht (In)	0.0
Yes	Refuge 1 Slope (%)	0.3	Yes	Gutter 1 Slope (%)	2.1
Yes	Refuge 1 X Slope (%)	1.6	Yes	Gutter 1 X Slope (%)	0.9
N/A	Painted X Walk1?	Yes	Yes	DWS 1 Provided?	Yes
N/A	X Walk 1 Direction	To E	Yes	DWS 1 Contrast?	Yes
N/A	X Walk 1 Width (In)	110.0	Yes	DWS 1 Length (In)	24.0
N/A	Road 1 Slope (%)	2.4	Yes	DWS 1 Full Width?	Yes
N/A	Road 1 X Slope (%)	1.4	No	DWS 1 Offset (In)	10.0
Yes	Refuge 2 Length (In)	64.0	Yes	Gutter 2 Ponding?	No
Yes	Refuge 2 Width (In)	73.0	Yes	Gutter 2 Lip Ht (In)	0.0
Yes	Refuge 2 Slope (%)	0.9	Yes	Gutter 2 Slope (%)	1.9
Yes	Refuge 2 X Slope (%)	1.8	No	Gutter 2 X Slope (%)	5.2
N/A	Painted X Walk2?	Yes	Yes	DWS 2 Provided?	Yes
N/A	X Walk 2 Direction	To SW	Yes	DWS 2 Contrast?	Yes
N/A	X Walk 2 Width (In)	110.0	Yes	DWS 2 Length (In)	24.0

N/A	Road 2 Slope (%)	3.4	Yes	DWS 2 Full Width?	Yes
N/A	Road 2 X Slope (%)	0.2	No	DWS 2 Offset (In)	12.0
N/A	Refuge 3 Length (in)	N/A	N/A	Gutter 3 Ponding?	N/A
N/A	Refuge 3 Width (in)	N/A	N/A	Gutter 3 Lip Ht (in)	N/A
N/A	Refuge 3 Slope (%)	N/A	N/A	Gutter 3 Slope (%)	N/A
N/A	Refuge 3 XSlope (%)	N/A	N/A	Gutter 3 XSlope (%)	N/A
N/A	Painted X Walk3?	N/A	N/A	DWS 3 Provided?	N/A
N/A	X Walk 3 Direction	N/A	N/A	DWS 3 Contrast?	N/A
N/A	X Walk 3 Width (in)	N/A	N/A	DWS 3 Length (in)	N/A
N/A	Road 3 Slope (%)	N/A	N/A	DWS 3 Full Width?	N/A
N/A	Road 3 XSlope (%)	N/A	N/A	DWS 3 Offset (in)	N/A
Yes	Any Obstructions?	N/A	N/A	Storm Grate/Utility Hazard?	No
N/A	Obstruction Type		N/A	Storm Grate/Utility Type	
N/A	Surface Condition	Good			N/A

Possible Solutions:

**Remove & Replace Detectable Warning System. Remove & Replace Gutter.**
