Access Compliance Report

Public Rights-of-Way

(Island Curb Cuts)

Intersection ID: 9648	Main Street: TIMBERBROOK_DR	Cross Street: TUCKASEEGEE_RD	Location: SW
ADA ID: 8BEC45301BA9	Curb Cut Type: MedianRefuge2	Initial Pass/Fail: Fail	Overall Compliance: No
Severity Score: 12.5			
Codes/Mitigation Info/Possible Solution		Field Measurements/Component Compliance

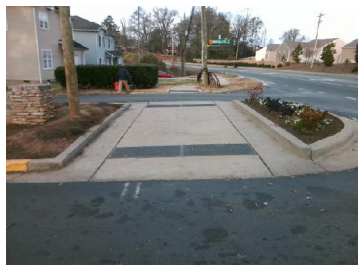
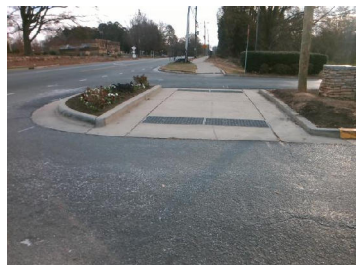
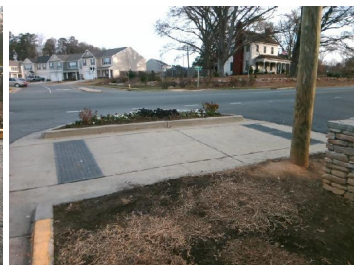
Compliance	Description	Data	Compliance	Description	Data
Yes	Refuge 1 Length (In)	115.0	N/A	Gutter 1 Ponding?	N/A
Yes	Refuge 1 Width (In)	144.0	N/A	Gutter 1 Lip Ht (In)	N/A
Yes	Refuge 1 Slope (%)	0.9	N/A	Gutter 1 Slope (%)	N/A
No	Refuge 1 X Slope (%)	6.5	N/A	Gutter 1 X Slope (%)	N/A
N/A	Painted X Walk1?	No	N/A	DWS 1 Provided?	N/A
N/A	X Walk 1 Direction	To SW	N/A	DWS 1 Contrast?	N/A
N/A	X Walk 1 Width (In)	N/A	N/A	DWS 1 Length (In)	N/A
N/A	Road 1 Slope (%)	4.3	N/A	DWS 1 Full Width?	N/A
N/A	Road 1 X Slope (%)	5.1	N/A	DWS 1 Offset (In)	N/A
Yes	Refuge 2 Length (In)	115.0	N/A	Gutter 2 Ponding?	N/A
Yes	Refuge 2 Width (In)	144.0	N/A	Gutter 2 Lip Ht (In)	N/A
Yes	Refuge 2 Slope (%)	2.0	N/A	Gutter 2 Slope (%)	N/A
No	Refuge 2 X Slope (%)	6.3	N/A	Gutter 2 X Slope (%)	N/A
N/A	Painted X Walk2?	No	N/A	DWS 2 Provided?	N/A
N/A	X Walk 2 Direction	To W	N/A	DWS 2 Contrast?	N/A
N/A	X Walk 2 Width (In)	N/A	N/A	DWS 2 Length (In)	N/A

Remove & Replace Entire Refuge.
