Access Compliance Report

Public Rights-of-Way

(Island Curb Cuts)

Intersection ID: 9925	Main Street: TENNYSON_DR	Cross Street: TUCKASEEGEE_RD	Location: S
ADA ID: 8C9AE060EC57	Curb Cut Type: MedianRefuge2	Initial Pass/Fail: Pass	Overall Compliance: No
Codes/Mitigation Info/Possible Solution		Field Measurements/Component Compliance	
Severity Score: 5.25

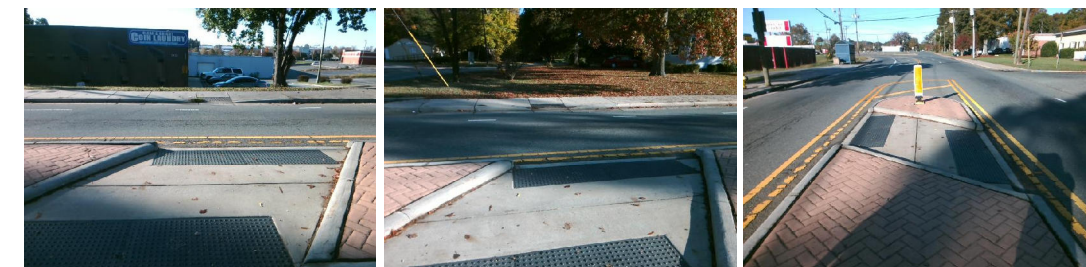
N/A	Road 2 Slope (%)	1.8	No	DWS 2 Full Width?	No
N/A	Road 2 X Slope (%)	2.3	Yes	DWS 2 Offset (In)	1.5
N/A	Refuge 3 Length (in)	N/A	N/A	Gutter 3 Ponding?	N/A
N/A	Refuge 3 Width (in)	N/A	N/A	Gutter 3 Lip Ht (in)	N/A
N/A	Refuge 3 Slope (%)	N/A	N/A	Gutter 3 Slope (%)	N/A
N/A	Refuge 3 XSlope (%)	N/A	N/A	Gutter 3 XSlope (%)	N/A
N/A	Painted X Walk3?	N/A	N/A	DWS 3 Provided?	N/A
N/A	X Walk 3 Direction	N/A	N/A	DWS 3 Contrast?	N/A
N/A	X Walk 3 Width (in)	N/A	N/A	DWS 3 Length (in)	N/A
N/A	Road 3 Slope (%)	N/A	N/A	DWS 3 Full Width?	N/A
N/A	Road 3 XSlope (%)	N/A	N/A	DWS 3 Offset (in)	N/A
Yes	Any Obstructions?	No	N/A	Storm Grate/Utility Hazard?	No
N/A	Obstruction Type		N/A	Storm Grate/Utility Type	
		N/A			N/A
N/A	Surface Condition	Good

Remove & Replace Detectable Warning System.
