Access Compliance Report

Public Rights-of-Way

(Island Curb Cuts)

Intersection ID: 10033070	Main Street: NORTH_COMMUNITY_HOUSE_RD	Cross Street: N/A	Location: S
ADA ID: 8CE2D44951D2	Curb Cut Type: MedianRefuge2	Initial Pass/Fail: Fail	Overall Compliance: No
Codes/Mitigation Info/Possible Solution		Field Measurements/Component Compliance

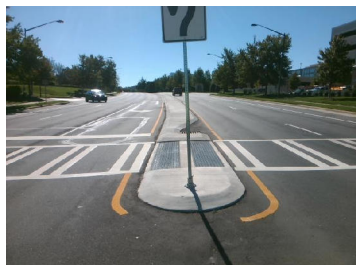
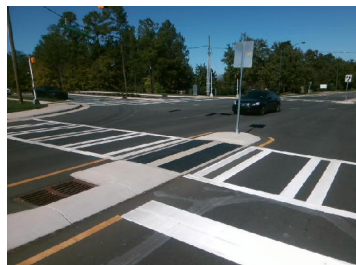
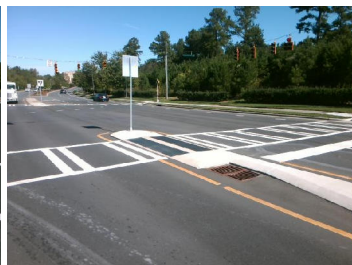
Compliance	Description	Data	Compliance	Description	Data
No	Refuge 1 Length (In)	33.5	N/A	Gutter 1 Ponding?	N/A
Yes	Refuge 1 Width (In)	120.0	N/A	Gutter 1 Lip Ht (In)	N/A
No	Refuge 1 Slope (%)	6.6	N/A	Gutter 1 Slope (%)	N/A
Yes	Refuge 1 X Slope (%)	1.3	N/A	Gutter 1 X Slope (%)	N/A
N/A	Painted X Walk1?	Yes	N/A	DWS 1 Provided?	N/A
N/A	X Walk 1 Direction	To E	N/A	DWS 1 Contrast?	N/A
N/A	X Walk 1 Width (In)	111.0	N/A	DWS 1 Length (In)	N/A
N/A	Road 1 Slope (%)	2.4	N/A	DWS 1 Full Width?	N/A
N/A	Road 1 X Slope (%)	7.5	N/A	DWS 1 Offset (In)	N/A
No	Refuge 2 Length (In)	33.5	N/A	Gutter 2 Ponding?	N/A
Yes	Refuge 2 Width (In)	120.0	N/A	Gutter 2 Lip Ht (In)	N/A
Yes	Refuge 2 Slope (%)	0.4	N/A	Gutter 2 Slope (%)	N/A
Yes	Refuge 2 X Slope (%)	1.7	N/A	Gutter 2 X Slope (%)	N/A
N/A	Painted X Walk2?	Yes	N/A	DWS 2 Provided?	N/A
N/A	X Walk 2 Direction	To W	N/A	DWS 2 Contrast?	N/A
N/A	X Walk 2 Width (In)	110.0	N/A	DWS 2 Length (In)	N/A

N/A	Road 2 Slope (%)	2.4	N/A	DWS 2 Full Width?	N/A
N/A	Road 2 X Slope (%)	1.8	N/A	DWS 2 Offset (In)	N/A
N/A	Refuge 3 Length (in)	N/A	N/A	Gutter 3 Ponding?	N/A
N/A	Refuge 3 Width (in)	N/A	N/A	Gutter 3 Lip Ht (in)	N/A
N/A	Refuge 3 Slope (%)	N/A	N/A	Gutter 3 Slope (%)	N/A
N/A	Refuge 3 XSlope (%)	N/A	N/A	Gutter 3 XSlope (%)	N/A
N/A	Painted X Walk3?	N/A	N/A	DWS 3 Provided?	N/A
N/A	X Walk 3 Direction	N/A	N/A	DWS 3 Contrast?	N/A
N/A	X Walk 3 Width (in)	N/A	N/A	DWS 3 Length (in)	N/A
N/A	Road 3 Slope (%)	N/A	N/A	DWS 3 Full Width?	N/A
N/A	Road 3 XSlope (%)	N/A	N/A	DWS 3 Offset (in)	N/A
Yes	Any Obstructions?	N/A	N/A	Storm Grate/Utility Hazard?	N/A
N/A	Obstruction Type		N/A	Storm Grate/Utility Type	
		N/A			N/A
N/A	Surface Condition	Good

Remove & Replace Entire Refuge.
