Access Compliance Report

Public Rights-of-Way

(Island Curb Cuts)

Intersection ID: 17169	Main Street: IDLEWILD_RD	Cross Street: CEDARS_EAST_CT	Location: NW
ADA ID: 8E6FD563147A	Curb Cut Type: MedianRefuge2	Initial Pass/Fail: Fail	Overall Compliance: No
Severity Score: 1.25			
Codes/Mitigation Info/Possible Solution		Field Measurements/Component Compliance

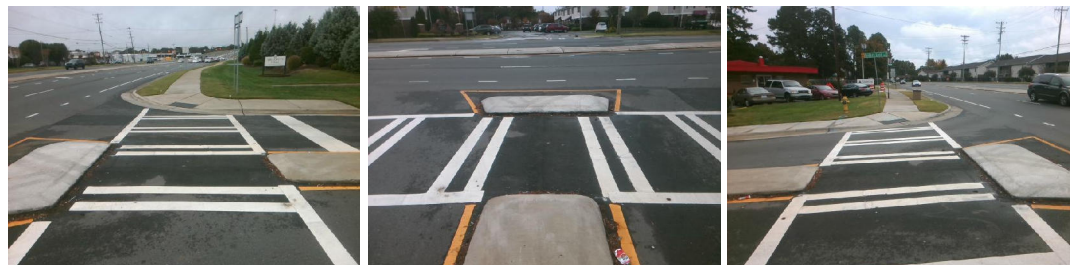
Compliance	Description	Data	Compliance	Description	Data
No	Refuge 1 Length (In)	22.0	N/A	Gutter 1 Ponding?	N/A
Yes	Refuge 1 Width (In)	120.0	N/A	Gutter 1 Lip Ht (In)	N/A
Yes	Refuge 1 Slope (%)	3.7	N/A	Gutter 1 Slope (%)	N/A
Yes	Refuge 1 X Slope (%)	4.0	N/A	Gutter 1 X Slope (%)	N/A
N/A	Painted X Walk1?	Yes	N/A	DWS 1 Provided?	N/A
N/A	X Walk 1 Direction	To SW	N/A	DWS 1 Contrast?	N/A
N/A	X Walk 1 Width (In)	111.0	N/A	DWS 1 Length (In)	N/A
N/A	Road 1 Slope (%)	3.5	N/A	DWS 1 Full Width?	N/A
N/A	Road 1 X Slope (%)	3.5	N/A	DWS 1 Offset (In)	N/A
No	Refuge 2 Length (In)	22.0	N/A	Gutter 2 Ponding?	N/A
Yes	Refuge 2 Width (In)	120.0	N/A	Gutter 2 Lip Ht (In)	N/A
Yes	Refuge 2 Slope (%)	0.3	N/A	Gutter 2 Slope (%)	N/A
Yes	Refuge 2 X Slope (%)	3.2	N/A	Gutter 2 X Slope (%)	N/A
N/A	Painted X Walk2?	Yes	N/A	DWS 2 Provided?	N/A
N/A	X Walk 2 Direction	To NE	N/A	DWS 2 Contrast?	N/A
N/A	X Walk 2 Width (In)	110.0	N/A	DWS 2 Length (In)	N/A

N/A	Road 2 Slope (%)	3.4	N/A	DWS 2 Full Width?	N/A
N/A	Road 2 X Slope (%)	0.5	N/A	DWS 2 Offset (In)	N/A
N/A	Refuge 3 Length (in)	N/A	N/A	Gutter 3 Ponding?	N/A
N/A	Refuge 3 Width (in)	N/A	N/A	Gutter 3 Lip Ht (in)	N/A
N/A	Refuge 3 Slope (%)	N/A	N/A	Gutter 3 Slope (%)	N/A
N/A	Refuge 3 XSlope (%)	N/A	N/A	Gutter 3 XSlope (%)	N/A
N/A	Painted X Walk3?	N/A	N/A	DWS 3 Provided?	N/A
N/A	X Walk 3 Direction	N/A	N/A	DWS 3 Contrast?	N/A
N/A	X Walk 3 Width (in)	N/A	N/A	DWS 3 Length (in)	N/A
N/A	Road 3 Slope (%)	N/A	N/A	DWS 3 Full Width?	N/A
N/A	Road 3 XSlope (%)	N/A	N/A	DWS 3 Offset (in)	N/A
Yes	Any Obstructions?	N/A	N/A	Storm Grate/Utility Hazard?	N/A
N/A	Obstruction Type		N/A	Storm Grate/Utility Type	
		N/A			N/A
N/A	Surface Condition	Good

Remove & Replace Entire Refuge.
