Access Compliance Report

Public Rights-of-Way

(Island Curb Cuts)

Intersection ID: 27397	Main Street: ELM_LN	Cross Street: BALLANTYNE_COMMONS_PY	Location: N
ADA ID: 8FAA072A5C9D	Curb Cut Type: MedianRefuge2	Initial Pass/Fail: Fail	Overall Compliance: No
		Severity Score: 0

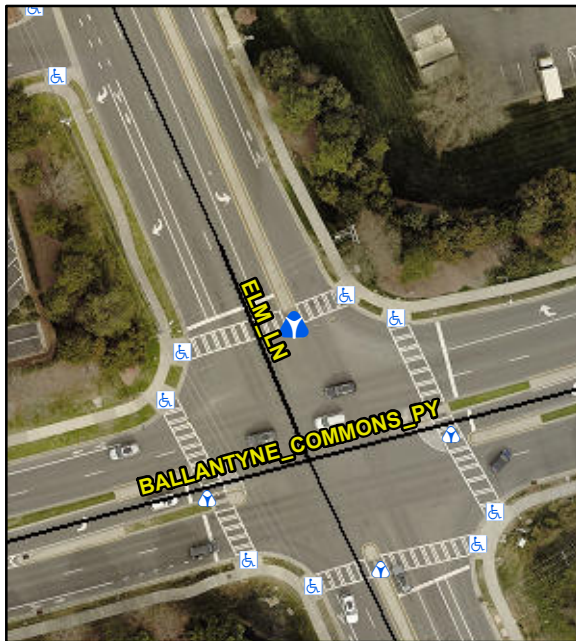
Compliance	Description	Data	Compliance	Description	Data
No	Refuge 1 Length (In)	35.5	N/A	Gutter 1 Ponding?	N/A
Yes	Refuge 1 Width (In)	98.0	N/A	Gutter 1 Lip Ht (In)	N/A
Yes	Refuge 1 Slope (%)	1.3	N/A	Gutter 1 Slope (%)	N/A
Yes	Refuge 1 X Slope (%)	2.4	N/A	Gutter 1 X Slope (%)	N/A
N/A	Painted X Walk1?	Yes	N/A	DWS 1 Provided?	N/A
N/A	X Walk 1 Direction	To NE	N/A	DWS 1 Contrast?	N/A
N/A	X Walk 1 Width (In)	111.0	N/A	DWS 1 Length (In)	N/A
N/A	Road 1 Slope (%)	1.3	N/A	DWS 1 Full Width?	N/A
N/A	Road 1 X Slope (%)	0.5	N/A	DWS 1 Offset (In)	N/A
No	Refuge 2 Length (In)	35.5	N/A	Gutter 2 Ponding?	N/A
Yes	Refuge 2 Width (In)	98.0	N/A	Gutter 2 Lip Ht (In)	N/A
Yes	Refuge 2 Slope (%)	0.6	N/A	Gutter 2 Slope (%)	N/A
Yes	Refuge 2 X Slope (%)	2.8	N/A	Gutter 2 X Slope (%)	N/A
N/A	Painted X Walk2?	Yes	N/A	DWS 2 Provided?	N/A
N/A	X Walk 2 Direction	To SW	N/A	DWS 2 Contrast?	N/A
N/A	X Walk 2 Width (In)	108.0	N/A	DWS 2 Length (In)	N/A

N/A	Road 2 Slope (%)	0.6	N/A	DWS 2 Full Width?	N/A
N/A	Road 2 X Slope (%)	2.8	N/A	DWS 2 Offset (In)	N/A
N/A	Refuge 3 Length (in)	N/A	N/A	Gutter 3 Ponding?	N/A
N/A	Refuge 3 Width (in)	N/A	N/A	Gutter 3 Lip Ht (in)	N/A
N/A	Refuge 3 Slope (%)	N/A	N/A	Gutter 3 Slope (%)	N/A
N/A	Refuge 3 XSlope (%)	N/A	N/A	Gutter 3 XSlope (%)	N/A
N/A	Painted X Walk3?	N/A	N/A	DWS 3 Provided?	N/A
N/A	X Walk 3 Direction	N/A	N/A	DWS 3 Contrast?	N/A
N/A	X Walk 3 Width (in)	N/A	N/A	DWS 3 Length (in)	N/A
N/A	Road 3 Slope (%)	N/A	N/A	DWS 3 Full Width?	N/A
N/A	Road 3 XSlope (%)	N/A	N/A	DWS 3 Offset (in)	N/A
Yes	Any Obstructions?	N/A	N/A	Storm Grate/Utility Hazard?	N/A
N/A	Obstruction Type		N/A	Storm Grate/Utility Type	
		N/A			N/A
N/A	Surface Condition	Good

Remove & Replace Entire Refuge.
