# Access Compliance Report

## Public Rights-of-Way

### (Island Curb Cuts)

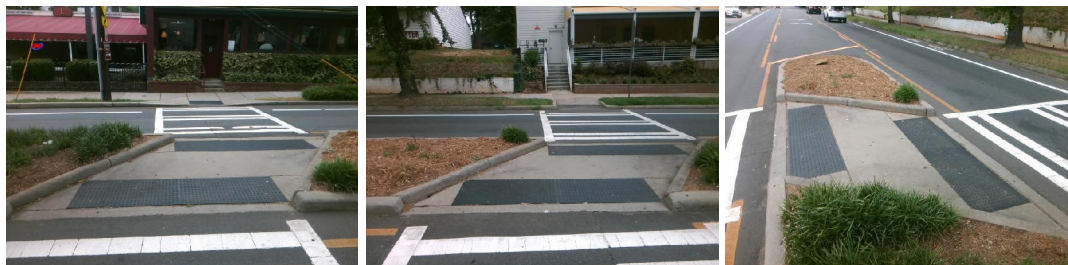
Intersection ID: 10025677	Main Street: EAST_BV	Cross Street: N/A	Location: N
ADA ID: 8FC6222EF554	Curb Cut Type: MedianRefuge2	Initial Pass/Fail: Fail	Overall Compliance: No
Severity Score: 1.25			
Codes/Mitigation Info/Possible Solution		Field Measurements/Component Compliance

Compliance	Description	Data	Compliance	Description	Data
Yes	Refuge 1 Length (In)	44.5	N/A	Gutter 1 Ponding?	N/A
Yes	Refuge 1 Width (In)	112.0	N/A	Gutter 1 Lip Ht (In)	N/A
Yes	Refuge 1 Slope (%)	3.4	N/A	Gutter 1 Slope (%)	N/A
Yes	Refuge 1 X Slope (%)	3.5	N/A	Gutter 1 X Slope (%)	N/A
N/A	Painted X Walk1?	Yes	N/A	DWS 1 Provided?	N/A
N/A	X Walk 1 Direction	To SW	N/A	DWS 1 Contrast?	N/A
N/A	X Walk 1 Width (In)	114.0	N/A	DWS 1 Length (In)	N/A
N/A	Road 1 Slope (%)	1.4	N/A	DWS 1 Full Width?	N/A
N/A	Road 1 X Slope (%)	2.4	N/A	DWS 1 Offset (In)	N/A
Yes	Refuge 2 Length (In)	44.5	N/A	Gutter 2 Ponding?	N/A
Yes	Refuge 2 Width (In)	112.0	N/A	Gutter 2 Lip Ht (In)	N/A
Yes	Refuge 2 Slope (%)	2.1	N/A	Gutter 2 Slope (%)	N/A
Yes	Refuge 2 X Slope (%)	3.6	N/A	Gutter 2 X Slope (%)	N/A
N/A	Painted X Walk2?	Yes	N/A	DWS 2 Provided?	N/A
N/A	X Walk 2 Direction	To NE	N/A	DWS 2 Contrast?	N/A
N/A	X Walk 2 Width (In)	112.0	N/A	DWS 2 Length (In)	N/A

N/A	Road 2 Slope (%)	2.4	N/A	DWS 2 Full Width?	N/A
N/A	Road 2 X Slope (%)	3.8	N/A	DWS 2 Offset (In)	N/A
N/A	Refuge 3 Length (in)	N/A	N/A	Gutter 3 Ponding?	N/A
N/A	Refuge 3 Width (in)	N/A	N/A	Gutter 3 Lip Ht (in)	N/A
N/A	Refuge 3 Slope (%)	N/A	N/A	Gutter 3 Slope (%)	N/A
N/A	Refuge 3 XSlope (%)	N/A	N/A	Gutter 3 XSlope (%)	N/A
N/A	Painted X Walk3?	N/A	N/A	DWS 3 Provided?	N/A
N/A	X Walk 3 Direction	N/A	N/A	DWS 3 Contrast?	N/A
N/A	X Walk 3 Width (in)	N/A	N/A	DWS 3 Length (in)	N/A
N/A	Road 3 Slope (%)	N/A	N/A	DWS 3 Full Width?	N/A
N/A	Road 3 XSlope (%)	N/A	N/A	DWS 3 Offset (in)	N/A
Yes	Any Obstructions?	N/A	N/A	Storm Grate/Utility Hazard?	N/A
N/A	Obstruction Type		N/A	Storm Grate/Utility Type	
		N/A			N/A
N/A	Surface Condition	Good

**Remove & Replace Entire Refuge.**
