Access Compliance Report

Public Rights-of-Way

(Island Curb Cuts)

Intersection ID: 15460	Main Street: CLANTON_RD	Cross Street: S_I-77_TO_CLANTON_RD_RA_SB	Location: NW
ADA ID: 904565E29219	Curb Cut Type: IslandRefuge3	Initial Pass/Fail: Fail	Overall Compliance: No
Severity Score: 36.25			
Codes/Mitigation Info/Possible Solution		Field Measurements/Component Compliance

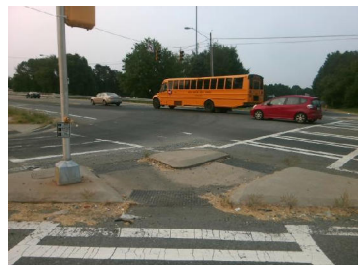
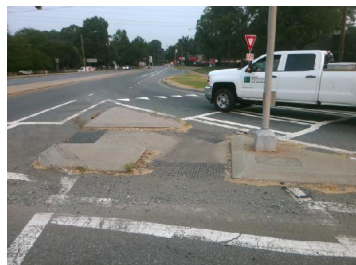
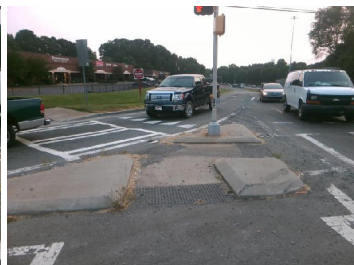
Compliance	Description	Data	Compliance	Description	Data
Yes	Refuge 1 Length (In)	56.0	N/A	Gutter 1 Ponding?	N/A
Yes	Refuge 1 Width (In)	60.0	N/A	Gutter 1 Lip Ht (In)	N/A
Yes	Refuge 1 Slope (%)	2.9	N/A	Gutter 1 Slope (%)	N/A
Yes	Refuge 1 X Slope (%)	0.8	N/A	Gutter 1 X Slope (%)	N/A
N/A	Painted X Walk1?	Yes	N/A	DWS 1 Provided?	N/A
N/A	X Walk 1 Direction	To N	N/A	DWS 1 Contrast?	N/A
N/A	X Walk 1 Width (In)	110.0	N/A	DWS 1 Length (In)	N/A
N/A	Road 1 Slope (%)	2.6	N/A	DWS 1 Full Width?	N/A
N/A	Road 1 X Slope (%)	0.3	N/A	DWS 1 Offset (In)	N/A
Yes	Refuge 2 Length (In)	61.0	N/A	Gutter 2 Ponding?	N/A
Yes	Refuge 2 Width (In)	60.0	N/A	Gutter 2 Lip Ht (In)	N/A
Yes	Refuge 2 Slope (%)	1.6	N/A	Gutter 2 Slope (%)	N/A
Yes	Refuge 2 X Slope (%)	0.9	N/A	Gutter 2 X Slope (%)	N/A
N/A	Painted X Walk2?	Yes	N/A	DWS 2 Provided?	N/A
N/A	X Walk 2 Direction	To SE	N/A	DWS 2 Contrast?	N/A
N/A	X Walk 2 Width (In)	110.0	N/A	DWS 2 Length (In)	N/A

N/A	Road 2 Slope (%)	2.4	N/A	DWS 2 Full Width?	N/A
N/A	Road 2 X Slope (%)	2.1	N/A	DWS 2 Offset (In)	N/A
Yes	Refuge 3 Length (in)	86.0	N/A	Gutter 3 Ponding?	N/A
Yes	Refuge 3 Width (in)	60.0	N/A	Gutter 3 Lip Ht (in)	N/A
Yes	Refuge 3 Slope (%)	2.6	N/A	Gutter 3 Slope (%)	N/A
Yes	Refuge 3 XSlope (%)	2.9	N/A	Gutter 3 XSlope (%)	N/A
N/A	Painted X Walk3?	Yes	N/A	DWS 3 Provided?	N/A
N/A	X Walk 3 Direction	To SW	N/A	DWS 3 Contrast?	N/A
N/A	X Walk 3 Width (in)	110.0	N/A	DWS 3 Length (in)	N/A
N/A	Road 3 Slope (%)	2.6	N/A	DWS 3 Full Width?	N/A
N/A	Road 3 XSlope (%)	1.8	N/A	DWS 3 Offset (in)	N/A
Yes	Any Obstructions?	N/A	N/A	Storm Grate/Utility Hazard?	N/A
N/A	Obstruction Type		N/A	Storm Grate/Utility Type	
N/A	Surface Condition	Good	N/A		N/A

Remove & Replace Entire Refuge.
