Access Compliance Report

Public Rights-of-Way

(Island Curb Cuts)

Intersection ID: 7486	Main Street: N_TRYON_ST	Cross Street: OWEN_BV	Location:	S
ADA ID: 913FFD6D46A7	Curb Cut Type: MedianRefuge2	Initial Pass/Fail: Pass	Overall Compliance: No	Severity Score: 0.25
Codes/Mitigation Info/Possible Solution		Field Measurements/Component Compliance

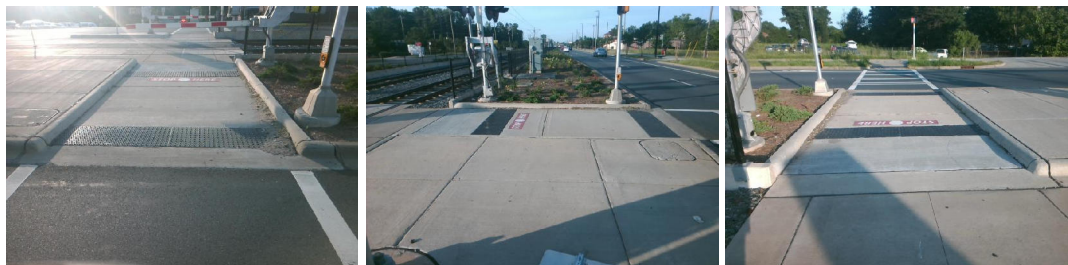
Compliance	Description	Data	Compliance	Description	Data
Yes	Refuge 1 Length (In)	115.0	Yes	Gutter 1 Ponding?	No
Yes	Refuge 1 Width (In)	120.0	Yes	Gutter 1 Lip Ht (In)	0.0
Yes	Refuge 1 Slope (%)	2.5	Yes	Gutter 1 Slope (%)	2.1
Yes	Refuge 1 X Slope (%)	0.0	Yes	Gutter 1 X Slope (%)	0.1
N/A	Painted X Walk1?	Yes	Yes	DWS 1 Provided?	Yes
N/A	X Walk 1 Direction	To W	Yes	DWS 1 Contrast?	Yes
N/A	X Walk 1 Width (In)	107.0	Yes	DWS 1 Length (In)	24.0
N/A	Road 1 Slope (%)	0.3	Yes	DWS 1 Full Width?	Yes
N/A	Road 1 X Slope (%)	2.0	Yes	DWS 1 Offset (In)	1.0
Yes	Refuge 2 Length (In)	115.0	Yes	Gutter 2 Ponding?	No
Yes	Refuge 2 Width (In)	120.0	Yes	Gutter 2 Lip Ht (In)	0.0
Yes	Refuge 2 Slope (%)	2.2	Yes	Gutter 2 Slope (%)	1.5
Yes	Refuge 2 X Slope (%)	0.6	Yes	Gutter 2 X Slope (%)	0.6
N/A	Painted X Walk2?	No	Yes	DWS 2 Provided?	Yes
N/A	X Walk 2 Direction	To E	Yes	DWS 2 Contrast?	Yes
N/A	X Walk 2 Width (In)	N/A	Yes	DWS 2 Length (In)	24.0

N/A	Road 2 Slope (%)	0.7	Yes	DWS 2 Full Width?	Yes
N/A	Road 2 X Slope (%)	0.3	No	DWS 2 Offset (In)	50.0
N/A	Refuge 3 Length (in)	N/A	N/A	Gutter 3 Ponding?	N/A
N/A	Refuge 3 Width (in)	N/A	N/A	Gutter 3 Lip Ht (in)	N/A
N/A	Refuge 3 Slope (%)	N/A	N/A	Gutter 3 Slope (%)	N/A
N/A	Refuge 3 XSlope (%)	N/A	N/A	Gutter 3 XSlope (%)	N/A
N/A	Painted X Walk3?	N/A	N/A	DWS 3 Provided?	N/A
N/A	X Walk 3 Direction	N/A	N/A	DWS 3 Contrast?	N/A
N/A	X Walk 3 Width (in)	N/A	N/A	DWS 3 Length (in)	N/A
N/A	Road 3 Slope (%)	N/A	N/A	DWS 3 Full Width?	N/A
N/A	Road 3 XSlope (%)	N/A	N/A	DWS 3 Offset (in)	N/A
Yes	Any Obstructions?	N/A	N/A	Storm Grate/Utility Hazard?	No
N/A	Obstruction Type		N/A	Storm Grate/Utility Type	
		N/A			N/A
N/A	Surface Condition	Good

Remove & Replace Detectable Warning System.
