Access Compliance Report

Public Rights-of-Way

(Island Curb Cuts)

Intersection ID: 7091	Main Street: BROOKSHIRE_BV	Cross Street: HOVIS_RD	Location:	N/A
ADA ID: 927E235B0EBA	Curb Cut Type: MedianRefuge2	Initial Pass/Fail: Fail	Overall Compliance: No	Severity Score: 0
Codes/Mitigation Info/Possible Solution		Field Measurements/Component Compliance

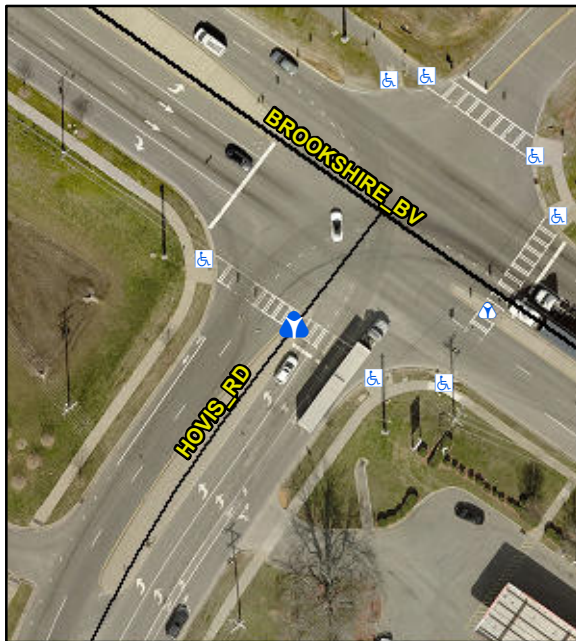
Compliance	Description	Data	Compliance	Description	Data
No	Refuge 1 Length (In)	29.0	N/A	Gutter 1 Ponding?	N/A
Yes	Refuge 1 Width (In)	96.0	N/A	Gutter 1 Lip Ht (In)	N/A
Yes	Refuge 1 Slope (%)	1.7	N/A	Gutter 1 Slope (%)	N/A
Yes	Refuge 1 X Slope (%)	2.5	N/A	Gutter 1 X Slope (%)	N/A
N/A	Painted X Walk1?	Yes	N/A	DWS 1 Provided?	N/A
N/A	X Walk 1 Direction	To SE	N/A	DWS 1 Contrast?	N/A
N/A	X Walk 1 Width (In)	112.0	N/A	DWS 1 Length (In)	N/A
N/A	Road 1 Slope (%)	2.1	N/A	DWS 1 Full Width?	N/A
N/A	Road 1 X Slope (%)	0.3	N/A	DWS 1 Offset (In)	N/A
No	Refuge 2 Length (In)	29.0	N/A	Gutter 2 Ponding?	N/A
Yes	Refuge 2 Width (In)	96.0	N/A	Gutter 2 Lip Ht (In)	N/A
Yes	Refuge 2 Slope (%)	1.1	N/A	Gutter 2 Slope (%)	N/A
Yes	Refuge 2 X Slope (%)	1.4	N/A	Gutter 2 X Slope (%)	N/A
N/A	Painted X Walk2?	Yes	N/A	DWS 2 Provided?	N/A
N/A	X Walk 2 Direction	To NW	N/A	DWS 2 Contrast?	N/A
N/A	X Walk 2 Width (In)	112.0	N/A	DWS 2 Length (In)	N/A

N/A	Road 2 Slope (%)	1.6	N/A	DWS 2 Full Width?	N/A
N/A	Road 2 X Slope (%)	0.2	N/A	DWS 2 Offset (In)	N/A
N/A	Refuge 3 Length (in)	N/A	N/A	Gutter 3 Ponding?	N/A
N/A	Refuge 3 Width (in)	N/A	N/A	Gutter 3 Lip Ht (in)	N/A
N/A	Refuge 3 Slope (%)	N/A	N/A	Gutter 3 Slope (%)	N/A
N/A	Refuge 3 XSlope (%)	N/A	N/A	Gutter 3 XSlope (%)	N/A
N/A	Painted X Walk3?	N/A	N/A	DWS 3 Provided?	N/A
N/A	X Walk 3 Direction	N/A	N/A	DWS 3 Contrast?	N/A
N/A	X Walk 3 Width (in)	N/A	N/A	DWS 3 Length (in)	N/A
N/A	Road 3 Slope (%)	N/A	N/A	DWS 3 Full Width?	N/A
N/A	Road 3 XSlope (%)	N/A	N/A	DWS 3 Offset (in)	N/A
Yes	Any Obstructions?	N/A	N/A	Storm Grate/Utility Hazard?	N/A
N/A	Obstruction Type		N/A	Storm Grate/Utility Type	
		N/A			N/A
N/A	Surface Condition	Good

Possible Solutions:

Remove & Replace Entire Refuge.
