Access Compliance Report

Public Rights-of-Way

(Island Curb Cuts)

Intersection ID: 25747	Main Street: HAMILTON_RD	Cross Street: SMITH_RD	Location: N
ADA ID: 9287162A5124	Curb Cut Type: MedianRefuge2	Initial Pass/Fail: Fail	Overall Compliance: No
Codes/Mitigation Info/Possible Solution		Field Measurements/Component Compliance

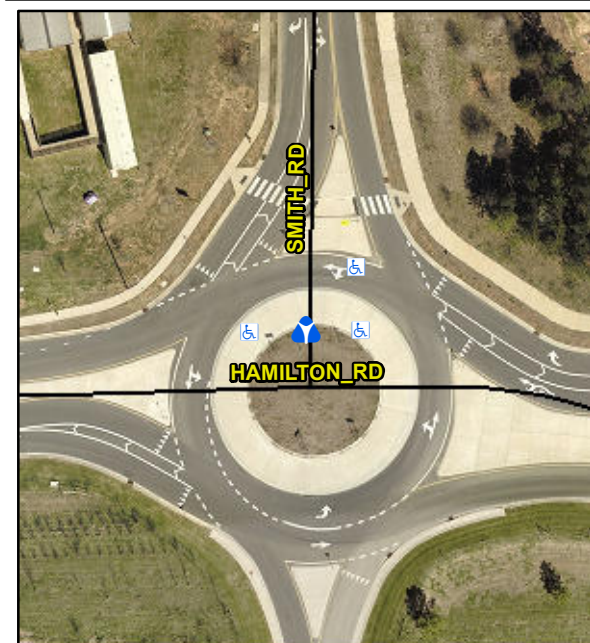
Compliance	Description	Data	Compliance	Description	Data
Yes	Refuge 1 Length (In)	124.5	N/A	Gutter 1 Ponding?	N/A
Yes	Refuge 1 Width (In)	110.0	N/A	Gutter 1 Lip Ht (In)	N/A
Yes	Refuge 1 Slope (%)	4.4	N/A	Gutter 1 Slope (%)	N/A
Yes	Refuge 1 X Slope (%)	3.9	N/A	Gutter 1 X Slope (%)	N/A
N/A	Painted X Walk1?	Yes	N/A	DWS 1 Provided?	N/A
N/A	X Walk 1 Direction	To NW	N/A	DWS 1 Contrast?	N/A
N/A	X Walk 1 Width (In)	122.0	N/A	DWS 1 Length (In)	N/A
N/A	Road 1 Slope (%)	4.4	N/A	DWS 1 Full Width?	N/A
N/A	Road 1 X Slope (%)	0.5	N/A	DWS 1 Offset (In)	N/A
Yes	Refuge 2 Length (In)	124.5	N/A	Gutter 2 Ponding?	N/A
Yes	Refuge 2 Width (In)	110.0	N/A	Gutter 2 Lip Ht (In)	N/A
Yes	Refuge 2 Slope (%)	0.7	N/A	Gutter 2 Slope (%)	N/A
Yes	Refuge 2 X Slope (%)	4.5	N/A	Gutter 2 X Slope (%)	N/A
N/A	Painted X Walk2?	Yes	N/A	DWS 2 Provided?	N/A
N/A	X Walk 2 Direction	To E	N/A	DWS 2 Contrast?	N/A
N/A	X Walk 2 Width (In)	121.0	N/A	DWS 2 Length (In)	N/A

N/A	Road 2 Slope (%)	3.4	N/A	DWS 2 Full Width?	N/A
N/A	Road 2 X Slope (%)	2.0	N/A	DWS 2 Offset (In)	N/A
N/A	Refuge 3 Length (in)	N/A	N/A	Gutter 3 Ponding?	N/A
N/A	Refuge 3 Width (in)	N/A	N/A	Gutter 3 Lip Ht (in)	N/A
N/A	Refuge 3 Slope (%)	N/A	N/A	Gutter 3 Slope (%)	N/A
N/A	Refuge 3 XSlope (%)	N/A	N/A	Gutter 3 XSlope (%)	N/A
N/A	Painted X Walk3?	N/A	N/A	DWS 3 Provided?	N/A
N/A	X Walk 3 Direction	N/A	N/A	DWS 3 Contrast?	N/A
N/A	X Walk 3 Width (in)	N/A	N/A	DWS 3 Length (in)	N/A
N/A	Road 3 Slope (%)	N/A	N/A	DWS 3 Full Width?	N/A
N/A	Road 3 XSlope (%)	N/A	N/A	DWS 3 Offset (in)	N/A
Yes	Any Obstructions?	N/A	N/A	Storm Grate/Utility Hazard?	N/A
N/A	Obstruction Type		N/A	Storm Grate/Utility Type	
		N/A			N/A
N/A	Surface Condition	Good

Remove & Replace Entire Refuge.
