Access Compliance Report

Public Rights-of-Way

(Island Curb Cuts)

Intersection ID: 44850	Main Street: STEELE_CREEK_RD	Cross Street: SHOPTON_RD_WEST	Location: S
ADA ID: 92A1D7908C07	Curb Cut Type: MedianRefuge2	Initial Pass/Fail: Fail	Overall Compliance: No
Codes/Mitigation Info/Possible Solution		Field Measurements/Component Compliance

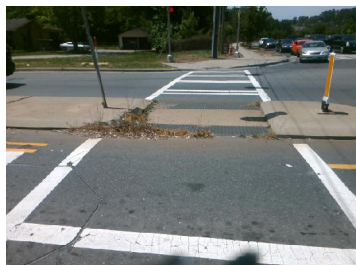
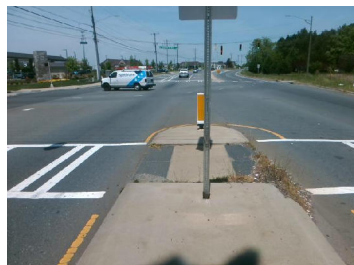
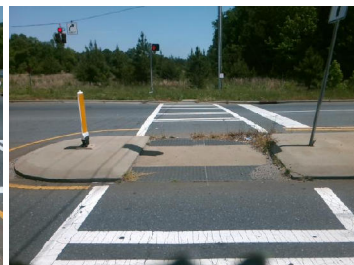
Compliance	Description	Data	Compliance	Description	Data
Yes	Refuge 1 Length (In)	48	N/A	Gutter 1 Ponding?	N/A
Yes	Refuge 1 Width (In)	98	N/A	Gutter 1 Lip Ht (In)	N/A
Yes	Refuge 1 Slope (%)	3.6	N/A	Gutter 1 Slope (%)	N/A
Yes	Refuge 1 X Slope (%)	2.4	N/A	Gutter 1 X Slope (%)	N/A
N/A	Painted X Walk1?	Yes	N/A	DWS 1 Provided?	N/A
N/A	X Walk 1 Direction	To W	N/A	DWS 1 Contrast?	N/A
N/A	X Walk 1 Width (In)	112	N/A	DWS 1 Length (In)	N/A
N/A	Road 1 Slope (%)	0.2	N/A	DWS 1 Full Width?	N/A
N/A	Road 1 X Slope (%)	4.1	N/A	DWS 1 Offset (In)	N/A
Yes	Refuge 2 Length (In)	48	N/A	Gutter 2 Ponding?	N/A
Yes	Refuge 2 Width (In)	98	N/A	Gutter 2 Lip Ht (In)	N/A
Yes	Refuge 2 Slope (%)	4.3	N/A	Gutter 2 Slope (%)	N/A
Yes	Refuge 2 X Slope (%)	0.7	N/A	Gutter 2 X Slope (%)	N/A
N/A	Painted X Walk2?	Yes	N/A	DWS 2 Provided?	N/A
N/A	X Walk 2 Direction	To E	N/A	DWS 2 Contrast?	N/A
N/A	X Walk 2 Width (In)	112	N/A	DWS 2 Length (In)	N/A
N/A	Road 2 Slope (%)	1.5	N/A	DWS 2 Full Width?	N/A

N/A	Road 2 X Slope (%)	4.4	N/A	DWS 2 Offset (In)	N/A
N/A	Refuge 3 Length (in)	N/A	N/A	Gutter 3 Ponding?	N/A
N/A	Refuge 3 Width (in)	N/A	N/A	Gutter 3 Lip Ht (in)	N/A
N/A	Refuge 3 Slope (%)	N/A	N/A	Gutter 3 Slope (%)	N/A
N/A	Refuge 3 XSlope (%)	N/A	N/A	Gutter 3 XSlope (%)	N/A
N/A	Painted X Walk3?	N/A	N/A	DWS 3 Provided?	N/A
N/A	X Walk 3 Direction	N/A	N/A	DWS 3 Contrast?	N/A
N/A	X Walk 3 Width (in)	N/A	N/A	DWS 3 Length (in)	N/A
N/A	Road 3 Slope (%)	N/A	N/A	DWS 3 Full Width?	N/A
N/A	Road 3 XSlope (%)	N/A	N/A	DWS 3 Offset (in)	N/A
Yes	Any Obstructions?	N/A	N/A	Storm Grate/Utility Hazard?	N/A
N/A	Obstruction Type		N/A	Storm Grate/Utility Type	
		N/A			N/A
N/A	Surface Condition	Good

Remove & Replace Entire Refuge.
