# Access Compliance Report

## Public Rights-of-Way

### (Island Curb Cuts)

Intersection ID: 5966	Main Street: SUNSTONE_DR	Cross Street: STATESVILLE_RD	Location: S
ADA ID: 94EFF1A7D1EA	Curb Cut Type: MedianRefuge2	Initial Pass/Fail: Pass	Overall Compliance: No
Codes/Mitigation Info/Possible Solution		Field Measurements/Component Compliance	
Severity Score: 0.25

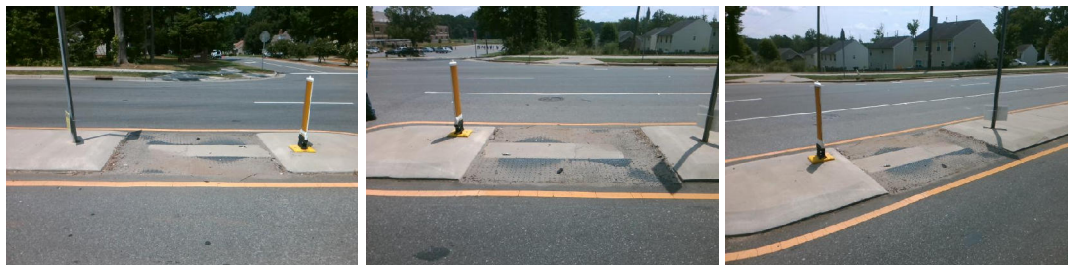
Compliance	Description	Data	Compliance	Description	Data
No	Refuge 1 Length (In)	35.5	No	Gutter 1 Ponding?	Yes
Yes	Refuge 1 Width (In)	96.0	Yes	Gutter 1 Lip Ht (In)	0.0
Yes	Refuge 1 Slope (%)	0.2	Yes	Gutter 1 Slope (%)	2.2
Yes	Refuge 1 X Slope (%)	0.8	Yes	Gutter 1 X Slope (%)	0.5
N/A	Painted X Walk1?	No	No	DWS 1 Provided?	Yes
N/A	X Walk 1 Direction	To E	N/A	DWS 1 Contrast?	Yes
N/A	X Walk 1 Width (In)	N/A	N/A	DWS 1 Length (In)	24.0
N/A	Road 1 Slope (%)	0.0	N/A	DWS 1 Full Width?	Yes
N/A	Road 1 X Slope (%)	2.0	N/A	DWS 1 Offset (In)	0.0
No	Refuge 2 Length (In)	35.5	No	Gutter 2 Ponding?	Yes
Yes	Refuge 2 Width (In)	96.0	Yes	Gutter 2 Lip Ht (In)	0.0
Yes	Refuge 2 Slope (%)	2.4	Yes	Gutter 2 Slope (%)	1.3
Yes	Refuge 2 X Slope (%)	0.8	Yes	Gutter 2 X Slope (%)	0.2
N/A	Painted X Walk2?	No	No	DWS 2 Provided?	Yes
N/A	X Walk 2 Direction	To W	N/A	DWS 2 Contrast?	Yes
N/A	X Walk 2 Width (In)	N/A	N/A	DWS 2 Length (In)	24.0
N/A	Road 2 Slope (%)	0.2	N/A	DWS 2 Full Width?	Yes

N/A	Road 2 X Slope (%)	1.4	N/A	DWS 2 Offset (In)	0.0
N/A	Refuge 3 Length (in)	N/A	N/A	Gutter 3 Ponding?	No
N/A	Refuge 3 Width (in)	N/A	N/A	Gutter 3 Lip Ht (in)	N/A
N/A	Refuge 3 Slope (%)	N/A	N/A	Gutter 3 Slope (%)	N/A
N/A	Refuge 3 XSlope (%)	N/A	N/A	Gutter 3 XSlope (%)	N/A
N/A	Painted X Walk3?	No	N/A	DWS 3 Provided?	N/A
N/A	X Walk 3 Direction	N/A	N/A	DWS 3 Contrast?	N/A
N/A	X Walk 3 Width (in)	N/A	N/A	DWS 3 Length (in)	N/A
N/A	Road 3 Slope (%)	N/A	N/A	DWS 3 Full Width?	N/A
N/A	Road 3 XSlope (%)	N/A	N/A	DWS 3 Offset (in)	N/A
Yes	Any Obstructions?	No	N/A	Storm Grate/Utility Hazard?	No
N/A	Obstruction Type		N/A	Storm Grate/Utility Type	
N/A	Surface Condition	Good	N/A		N/A

**Remove & Replace Entire Refuge.  
Fix Gutter Ponding.**

Total Cost: \$ 4000.00
