Access Compliance Report

Public Rights-of-Way

(Island Curb Cuts)

Intersection ID: 12937	Main Street: E_W_T_HARRIS_BV	Cross Street: HICKORY_GROVE_RD	Location: S
ADA ID: 9555EDC82C46	Curb Cut Type: MedianRefuge2	Initial Pass/Fail: Pass	Overall Compliance: No
Severity Score: 0			
Codes/Mitigation Info/Possible Solution		Field Measurements/Component Compliance

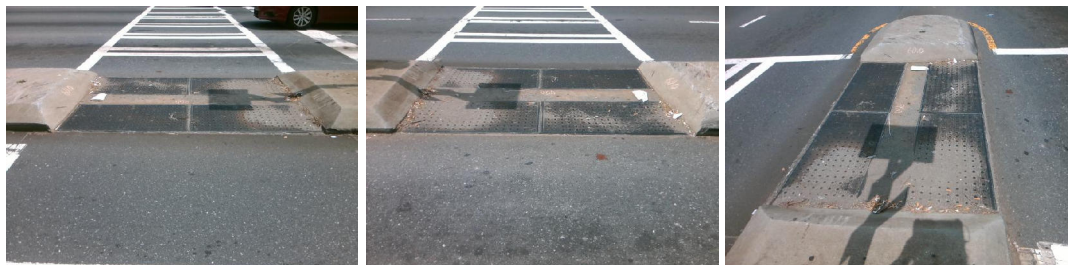
Compliance	Description	Data	Compliance	Description	Data
No	Refuge 1 Length (In)	30.0	Yes	Gutter 1 Ponding?	No
Yes	Refuge 1 Width (In)	95.0	Yes	Gutter 1 Lip Ht (In)	0.0
Yes	Refuge 1 Slope (%)	0.8	Yes	Gutter 1 Slope (%)	3.2
Yes	Refuge 1 X Slope (%)	0.1	Yes	Gutter 1 X Slope (%)	0.5
N/A	Painted X Walk1?	Yes	No	DWS 1 Provided?	Yes
N/A	X Walk 1 Direction	To NE	N/A	DWS 1 Contrast?	Yes
N/A	X Walk 1 Width (In)	111.5	N/A	DWS 1 Length (In)	24.0
N/A	Road 1 Slope (%)	0.8	N/A	DWS 1 Full Width?	Yes
N/A	Road 1 X Slope (%)	0.2	N/A	DWS 1 Offset (In)	0.0
No	Refuge 2 Length (In)	30.0	Yes	Gutter 2 Ponding?	No
Yes	Refuge 2 Width (In)	95.0	Yes	Gutter 2 Lip Ht (In)	0.0
Yes	Refuge 2 Slope (%)	0.5	Yes	Gutter 2 Slope (%)	3.3
Yes	Refuge 2 X Slope (%)	0.2	Yes	Gutter 2 X Slope (%)	0.4
N/A	Painted X Walk2?	Yes	No	DWS 2 Provided?	Yes
N/A	X Walk 2 Direction	To SW	N/A	DWS 2 Contrast?	Yes
N/A	X Walk 2 Width (In)	111.0	N/A	DWS 2 Length (In)	24.0

N/A	Road 2 Slope (%)	0.7	N/A	DWS 2 Full Width?	Yes
N/A	Road 2 X Slope (%)	3.8	N/A	DWS 2 Offset (In)	0.0
N/A	Refuge 3 Length (in)	N/A	N/A	Gutter 3 Ponding?	No
N/A	Refuge 3 Width (in)	N/A	N/A	Gutter 3 Lip Ht (in)	N/A
N/A	Refuge 3 Slope (%)	N/A	N/A	Gutter 3 Slope (%)	N/A
N/A	Refuge 3 XSlope (%)	N/A	N/A	Gutter 3 XSlope (%)	N/A
N/A	Painted X Walk3?	No	N/A	DWS 3 Provided?	N/A
N/A	X Walk 3 Direction	N/A	N/A	DWS 3 Contrast?	N/A
N/A	X Walk 3 Width (in)	N/A	N/A	DWS 3 Length (in)	N/A
N/A	Road 3 Slope (%)	N/A	N/A	DWS 3 Full Width?	N/A
N/A	Road 3 XSlope (%)	N/A	N/A	DWS 3 Offset (in)	N/A
Yes	Any Obstructions?	No	N/A	Storm Grate/Utility Hazard?	No
N/A	Obstruction Type		N/A	Storm Grate/Utility Type	
		N/A			N/A
N/A	Surface Condition	Good

Possible Solutions:

Remove & Replace Entire Refuge.
