Access Compliance Report

Public Rights-of-Way

(Island Curb Cuts)

Intersection ID: 8857	Main Street: DORTON_ST	Cross Street: N_TRYON_ST	Location: W
ADA ID: 95618BA2F866	Curb Cut Type: MedianRefuge2	Initial Pass/Fail: Fail	Overall Compliance: No
Codes/Mitigation Info/Possible Solution		Field Measurements/Component Compliance	
Severity Score: 15

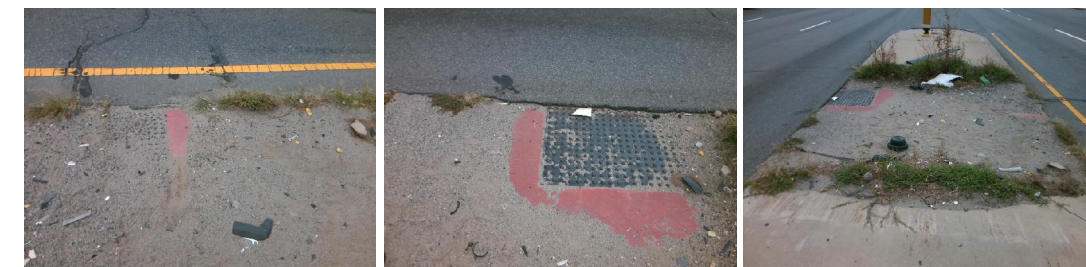
N/A	Road 2 Slope (%)	2.8	N/A	DWS 2 Full Width?	N/A
N/A	Road 2 X Slope (%)	4.0	N/A	DWS 2 Offset (In)	N/A
N/A	Refuge 3 Length (in)	N/A	N/A	Gutter 3 Ponding?	N/A
N/A	Refuge 3 Width (in)	N/A	N/A	Gutter 3 Lip Ht (in)	N/A
N/A	Refuge 3 Slope (%)	N/A	N/A	Gutter 3 Slope (%)	N/A
N/A	Refuge 3 XSlope (%)	N/A	N/A	Gutter 3 XSlope (%)	N/A
N/A	Painted X Walk3?	No	N/A	DWS 3 Provided?	N/A
N/A	X Walk 3 Direction	N/A	N/A	DWS 3 Contrast?	N/A
N/A	X Walk 3 Width (in)	N/A	N/A	DWS 3 Length (in)	N/A
N/A	Road 3 Slope (%)	N/A	N/A	DWS 3 Full Width?	N/A
N/A	Road 3 XSlope (%)	N/A	N/A	DWS 3 Offset (in)	N/A
Yes	Any Obstructions?	N/A	N/A	Storm Grate/Utility Hazard?	N/A
N/A	Obstruction Type		N/A	Storm Grate/Utility Type	
		N/A			N/A
No	Surface Condition	Poor

Remove & Replace Entire Refuge.
