# Access Compliance Report

## Public Rights-of-Way

### (Island Curb Cuts)

Intersection ID: 6640	Main Street: ARVIN_DR	Cross Street: COCHRANE_DR	Location: S
ADA ID: 96A075A15224	Curb Cut Type: MedianRefuge2	Initial Pass/Fail: Pass	Overall Compliance: No
Severity Score: 7.75			
Codes/Mitigation Info/Possible Solution		Field Measurements/Component Compliance

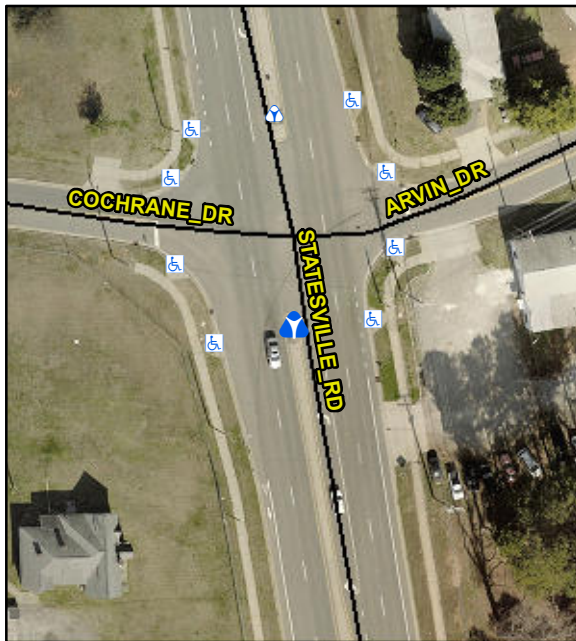
Compliance	Description	Data	Compliance	Description	Data
Yes	Refuge 1 Length (In)	36.0	No	Gutter 1 Ponding?	Yes
Yes	Refuge 1 Width (In)	96.5	No	Gutter 1 Lip Ht (In)	0.5
Yes	Refuge 1 Slope (%)	1.3	Yes	Gutter 1 Slope (%)	2.6
Yes	Refuge 1 X Slope (%)	0.4	Yes	Gutter 1 X Slope (%)	0.7
N/A	Painted X Walk1?	No	Yes	DWS 1 Provided?	Yes
N/A	X Walk 1 Direction	To E	Yes	DWS 1 Contrast?	Yes
N/A	X Walk 1 Width (In)	N/A	Yes	DWS 1 Length (In)	24.0
N/A	Road 1 Slope (%)	0.7	Yes	DWS 1 Full Width?	Yes
N/A	Road 1 X Slope (%)	4.3	Yes	DWS 1 Offset (In)	0.0
Yes	Refuge 2 Length (In)	36.0	No	Gutter 2 Ponding?	Yes
Yes	Refuge 2 Width (In)	96.5	Yes	Gutter 2 Lip Ht (In)	0.0
Yes	Refuge 2 Slope (%)	2.8	Yes	Gutter 2 Slope (%)	2.4
Yes	Refuge 2 X Slope (%)	0.7	Yes	Gutter 2 X Slope (%)	0.9
N/A	Painted X Walk2?	No	Yes	DWS 2 Provided?	Yes
N/A	X Walk 2 Direction	To W	Yes	DWS 2 Contrast?	Yes
N/A	X Walk 2 Width (In)	N/A	Yes	DWS 2 Length (In)	24.0

**Fix Gutter Ponding. Grind Gutter Lip.**
