Access Compliance Report

Public Rights-of-Way

(Island Curb Cuts)

Intersection ID: 24549	Main Street: I-485_RA	Cross Street: SOUTH_BV	Location: SE
ADA ID: 97D105EBD00F	Curb Cut Type: MedianRefuge2	Initial Pass/Fail: Fail	Overall Compliance: No
Codes/Mitigation Info/Possible Solution		Field Measurements/Component Compliance	
Severity Score: 0

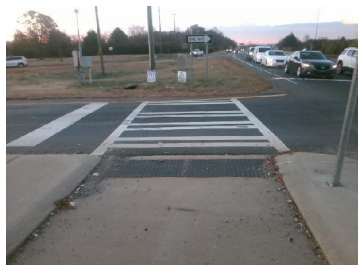
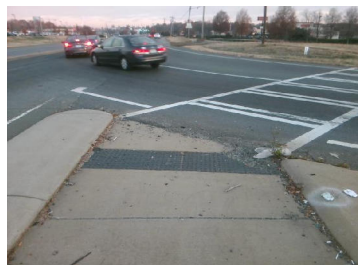
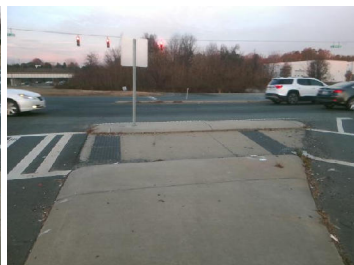
Compliance	Description	Data	Compliance	Description	Data
Yes	Refuge 1 Length (In)	90.0	N/A	Gutter 1 Ponding?	N/A
Yes	Refuge 1 Width (In)	101.0	N/A	Gutter 1 Lip Ht (In)	N/A
Yes	Refuge 1 Slope (%)	1.5	N/A	Gutter 1 Slope (%)	N/A
Yes	Refuge 1 X Slope (%)	4.1	N/A	Gutter 1 X Slope (%)	N/A
N/A	Painted X Walk1?	Yes	N/A	DWS 1 Provided?	N/A
N/A	X Walk 1 Direction	To NE	N/A	DWS 1 Contrast?	N/A
N/A	X Walk 1 Width (In)	122.0	N/A	DWS 1 Length (In)	N/A
N/A	Road 1 Slope (%)	2.2	N/A	DWS 1 Full Width?	N/A
N/A	Road 1 X Slope (%)	0.7	N/A	DWS 1 Offset (In)	N/A
Yes	Refuge 2 Length (In)	90.0	N/A	Gutter 2 Ponding?	N/A
Yes	Refuge 2 Width (In)	101.0	N/A	Gutter 2 Lip Ht (In)	N/A
Yes	Refuge 2 Slope (%)	0.2	N/A	Gutter 2 Slope (%)	N/A
Yes	Refuge 2 X Slope (%)	2.7	N/A	Gutter 2 X Slope (%)	N/A
N/A	Painted X Walk2?	Yes	N/A	DWS 2 Provided?	N/A
N/A	X Walk 2 Direction	To S	N/A	DWS 2 Contrast?	N/A
N/A	X Walk 2 Width (In)	113.0	N/A	DWS 2 Length (In)	N/A

N/A	Road 2 Slope (%)	2.4	N/A	DWS 2 Full Width?	N/A
N/A	Road 2 X Slope (%)	4.8	N/A	DWS 2 Offset (In)	N/A
N/A	Refuge 3 Length (in)	N/A	N/A	Gutter 3 Ponding?	N/A
N/A	Refuge 3 Width (in)	N/A	N/A	Gutter 3 Lip Ht (in)	N/A
N/A	Refuge 3 Slope (%)	N/A	N/A	Gutter 3 Slope (%)	N/A
N/A	Refuge 3 XSlope (%)	N/A	N/A	Gutter 3 XSlope (%)	N/A
N/A	Painted X Walk3?	N/A	N/A	DWS 3 Provided?	N/A
N/A	X Walk 3 Direction	N/A	N/A	DWS 3 Contrast?	N/A
N/A	X Walk 3 Width (in)	N/A	N/A	DWS 3 Length (in)	N/A
N/A	Road 3 Slope (%)	N/A	N/A	DWS 3 Full Width?	N/A
N/A	Road 3 XSlope (%)	N/A	N/A	DWS 3 Offset (in)	N/A
Yes	Any Obstructions?	N/A	N/A	Storm Grate/Utility Hazard?	N/A
N/A	Obstruction Type		N/A	Storm Grate/Utility Type	
		N/A			N/A
N/A	Surface Condition	Good

Remove & Replace Entire Refuge.
