Access Compliance Report

Public Rights-of-Way

(Island Curb Cuts)

| Intersection ID: 28003 | Main Street: COMMUNITY_HOUSE_RD | Cross Street: WILLOW_ROCK_DR | Location: W |

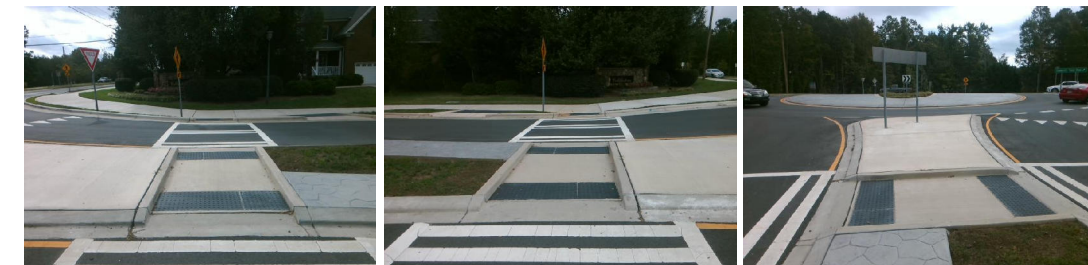
| ADA ID: 9826BE290C46 | Curb Cut Type: MedianRefuge2 | Initial Pass/Fail: Fail | Overall Compliance: No |
| Severity Score: 1.25 | | | |

Possible Solutions:

Remove & Replace Entire Refuge.
