# Access Compliance Report

## Public Rights-of-Way

### (Island Curb Cuts)

Intersection ID: 8739	Main Street: N_TRYON_ST	Cross Street: W_EASTWAY_DR	Location: SE
ADA ID: 9A35AFB9BFB3	Curb Cut Type: IslandRefuge3	Initial Pass/Fail: Pass	Overall Compliance: No
Severity Score: 12.75

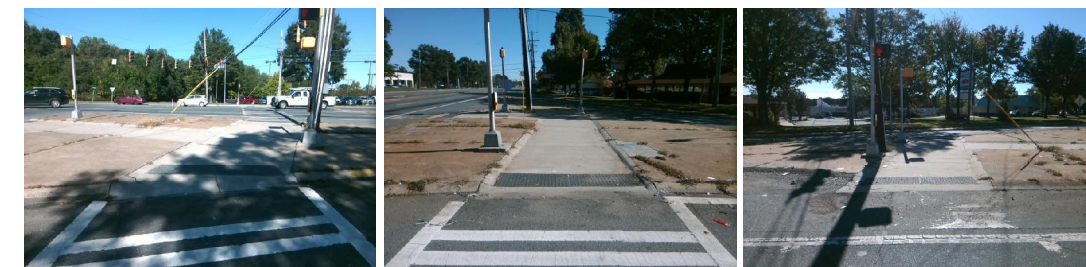
N/A	Road 2 Slope (%)	0.8	Yes	DWS 2 Full Width?	Yes
N/A	Road 2 X Slope (%)	1.6	Yes	DWS 2 Offset (In)	0.0
Yes	Refuge 3 Length (in)	197.0	Yes	Gutter 3 Ponding?	No
Yes	Refuge 3 Width (in)	97.0	No	Gutter 3 Lip Ht (in)	0.5
Yes	Refuge 3 Slope (%)	2.2	Yes	Gutter 3 Slope (%)	2.3
Yes	Refuge 3 XSlope (%)	0.6	Yes	Gutter 3 XSlope (%)	1.0
N/A	Painted X Walk3?	Yes	Yes	DWS 3 Provided?	Yes
N/A	X Walk 3 Direction	To NW	Yes	DWS 3 Contrast?	Yes
N/A	X Walk 3 Width (in)	109.5	Yes	DWS 3 Length (in)	24.0
N/A	Road 3 Slope (%)	0.7	Yes	DWS 3 Full Width?	Yes
N/A	Road 3 XSlope (%)	0.5	Yes	DWS 3 Offset (in)	0.0
Yes	Any Obstructions?	No	N/A	Storm Grate/Utility Hazard?	No
N/A	Obstruction Type	N/A	N/A	Storm Grate/Utility Type	N/A
N/A	Surface Condition	Good

**Grind Gutter Lip.**
