Access Compliance Report

Public Rights-of-Way

(Island Curb Cuts)

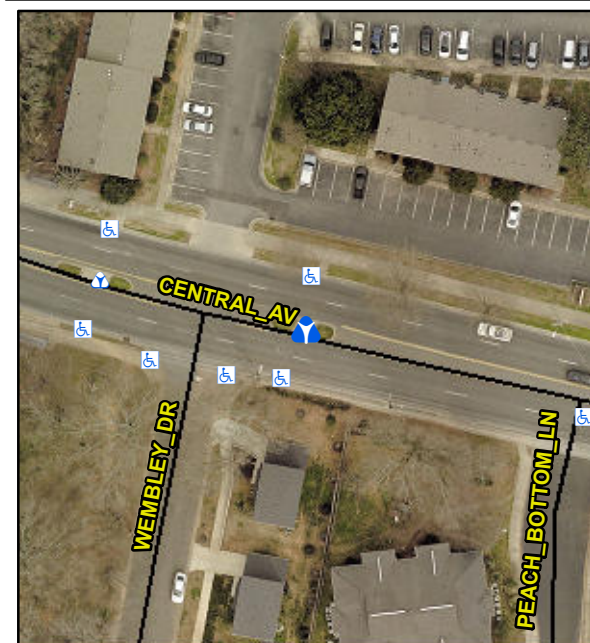
Intersection ID: 13588	Main Street: CENTRAL_AV	Cross Street: WEMBLEY_DR	Location: E
ADA ID: 9AA281C9D6AB	Curb Cut Type: MedianRefuge2	Initial Pass/Fail: Fail	Overall Compliance: No
Severity Score: 1.25			
Codes/Mitigation Info/Possible Solution		Field Measurements/Component Compliance

Compliance	Description	Data	Compliance	Description	Data
Yes	Refuge 1 Length (In)	51.0	N/A	Gutter 1 Ponding?	N/A
Yes	Refuge 1 Width (In)	118.0	N/A	Gutter 1 Lip Ht (In)	N/A
Yes	Refuge 1 Slope (%)	1.2	N/A	Gutter 1 Slope (%)	N/A
Yes	Refuge 1 X Slope (%)	3.9	N/A	Gutter 1 X Slope (%)	N/A
N/A	Painted X Walk1?	No	N/A	DWS 1 Provided?	N/A
N/A	X Walk 1 Direction	To S	N/A	DWS 1 Contrast?	N/A
N/A	X Walk 1 Width (In)	N/A	N/A	DWS 1 Length (In)	N/A
N/A	Road 1 Slope (%)	4.6	N/A	DWS 1 Full Width?	N/A
N/A	Road 1 X Slope (%)	2.0	N/A	DWS 1 Offset (In)	N/A
Yes	Refuge 2 Length (In)	51.0	N/A	Gutter 2 Ponding?	N/A
Yes	Refuge 2 Width (In)	118.0	N/A	Gutter 2 Lip Ht (In)	N/A
Yes	Refuge 2 Slope (%)	2.3	N/A	Gutter 2 Slope (%)	N/A
Yes	Refuge 2 X Slope (%)	4.6	N/A	Gutter 2 X Slope (%)	N/A
N/A	Painted X Walk2?	No	N/A	DWS 2 Provided?	N/A
N/A	X Walk 2 Direction	To N	N/A	DWS 2 Contrast?	N/A
N/A	X Walk 2 Width (In)	N/A	N/A	DWS 2 Length (In)	N/A

N/A	Road 2 Slope (%)	4.2	N/A	DWS 2 Full Width?	N/A
N/A	Road 2 X Slope (%)	7.2	N/A	DWS 2 Offset (In)	N/A
N/A	Refuge 3 Length (in)	N/A	N/A	Gutter 3 Ponding?	N/A
N/A	Refuge 3 Width (in)	N/A	N/A	Gutter 3 Lip Ht (in)	N/A
N/A	Refuge 3 Slope (%)	N/A	N/A	Gutter 3 Slope (%)	N/A
N/A	Refuge 3 XSlope (%)	N/A	N/A	Gutter 3 XSlope (%)	N/A
N/A	Painted X Walk3?	N/A	N/A	DWS 3 Provided?	N/A
N/A	X Walk 3 Direction	N/A	N/A	DWS 3 Contrast?	N/A
N/A	X Walk 3 Width (in)	N/A	N/A	DWS 3 Length (in)	N/A
N/A	Road 3 Slope (%)	N/A	N/A	DWS 3 Full Width?	N/A
N/A	Road 3 XSlope (%)	N/A	N/A	DWS 3 Offset (in)	N/A
Yes	Any Obstructions?	N/A	N/A	Storm Grate/Utility Hazard?	N/A
N/A	Obstruction Type		N/A	Storm Grate/Utility Type	
		N/A			N/A
N/A	Surface Condition	Good

Remove & Replace Entire Refuge.
