Access Compliance Report

Public Rights-of-Way

(Island Curb Cuts)

Intersection ID: 28389	Main Street: ARDREY_KELL_RD	Cross Street: LANCASTER_HY	Location: NW
ADA ID: 9B72E7B850A8	Curb Cut Type: IslandRefuge3	Initial Pass/Fail: Fail	Overall Compliance: No
Severity Score: 35			
Codes/Mitigation Info/Possible Solution		Field Measurements/Component Compliance

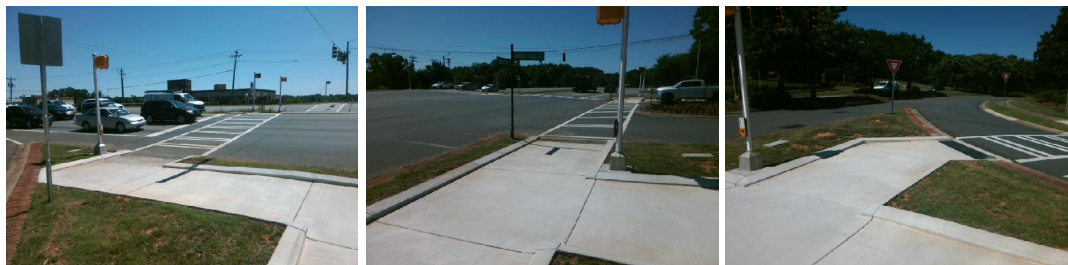
Compliance	Description	Data	Compliance	Description	Data
Yes	Refuge 1 Length (In)	64.0	N/A	Gutter 1 Ponding?	N/A
Yes	Refuge 1 Width (In)	98.0	N/A	Gutter 1 Lip Ht (In)	N/A
Yes	Refuge 1 Slope (%)	1.9	N/A	Gutter 1 Slope (%)	N/A
Yes	Refuge 1 X Slope (%)	0.2	N/A	Gutter 1 X Slope (%)	N/A
N/A	Painted X Walk1?	Yes	N/A	DWS 1 Provided?	N/A
N/A	X Walk 1 Direction	To E	N/A	DWS 1 Contrast?	N/A
N/A	X Walk 1 Width (In)	110.0	N/A	DWS 1 Length (In)	N/A
N/A	Road 1 Slope (%)	0.1	N/A	DWS 1 Full Width?	N/A
N/A	Road 1 X Slope (%)	5.1	N/A	DWS 1 Offset (In)	N/A
Yes	Refuge 2 Length (In)	159.0	N/A	Gutter 2 Ponding?	N/A
Yes	Refuge 2 Width (In)	98.0	N/A	Gutter 2 Lip Ht (In)	N/A
Yes	Refuge 2 Slope (%)	0.3	N/A	Gutter 2 Slope (%)	N/A
Yes	Refuge 2 X Slope (%)	0.1	N/A	Gutter 2 X Slope (%)	N/A
N/A	Painted X Walk2?	Yes	N/A	DWS 2 Provided?	N/A
N/A	X Walk 2 Direction	To S	N/A	DWS 2 Contrast?	N/A
N/A	X Walk 2 Width (In)	110.0	N/A	DWS 2 Length (In)	N/A

N/A	Road 2 Slope (%)	0.8	N/A	DWS 2 Full Width?	N/A
N/A	Road 2 X Slope (%)	1.3	N/A	DWS 2 Offset (In)	N/A
Yes	Refuge 3 Length (in)	64.0	N/A	Gutter 3 Ponding?	N/A
Yes	Refuge 3 Width (in)	97.0	N/A	Gutter 3 Lip Ht (in)	N/A
Yes	Refuge 3 Slope (%)	0.6	N/A	Gutter 3 Slope (%)	N/A
Yes	Refuge 3 XSlope (%)	3.4	N/A	Gutter 3 XSlope (%)	N/A
N/A	Painted X Walk3?	Yes	N/A	DWS 3 Provided?	N/A
N/A	X Walk 3 Direction	To NW	N/A	DWS 3 Contrast?	N/A
N/A	X Walk 3 Width (in)	110.0	N/A	DWS 3 Length (in)	N/A
N/A	Road 3 Slope (%)	2.2	N/A	DWS 3 Full Width?	N/A
N/A	Road 3 XSlope (%)	0.2	N/A	DWS 3 Offset (in)	N/A
Yes	Any Obstructions?	N/A	N/A	Storm Grate/Utility Hazard?	N/A
N/A	Obstruction Type		N/A	Storm Grate/Utility Type	
			N/A		N/A
N/A	Surface Condition	Good

Remove & Replace Entire Refuge.
