Access Compliance Report

Public Rights-of-Way

(Island Curb Cuts)

Intersection ID: 11058	Main Street: N I-77 EXIT 10B_RA	Cross Street: W 5TH_ST	Location: NE
ADA ID: 9D9B25E13BD9	Curb Cut Type: IslandRefuge2	Initial Pass/Fail: Fail	Overall Compliance: No
Codes/Mitigation Info/Possible Solution		Field Measurements/Component Compliance

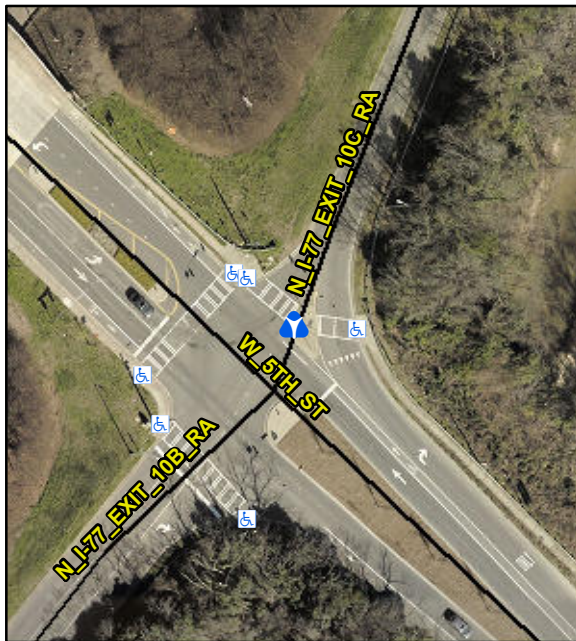
Compliance	Description	Data	Compliance	Description	Data
Yes	Refuge 1 Length (In)	51.0	N/A	Gutter 1 Ponding?	N/A
No	Refuge 1 Width (In)	48.0	N/A	Gutter 1 Lip Ht (In)	N/A
Yes	Refuge 1 Slope (%)	3.6	N/A	Gutter 1 Slope (%)	N/A
Yes	Refuge 1 X Slope (%)	1.1	N/A	Gutter 1 X Slope (%)	N/A
N/A	Painted X Walk1?	Yes	N/A	DWS 1 Provided?	N/A
N/A	X Walk 1 Direction	To N	N/A	DWS 1 Contrast?	N/A
N/A	X Walk 1 Width (In)	113.0	N/A	DWS 1 Length (In)	N/A
N/A	Road 1 Slope (%)	2.3	N/A	DWS 1 Full Width?	N/A
N/A	Road 1 X Slope (%)	0.9	N/A	DWS 1 Offset (In)	N/A
Yes	Refuge 2 Length (In)	51.0	N/A	Gutter 2 Ponding?	N/A
No	Refuge 2 Width (In)	48.0	N/A	Gutter 2 Lip Ht (In)	N/A
Yes	Refuge 2 Slope (%)	0.7	N/A	Gutter 2 Slope (%)	N/A
Yes	Refuge 2 X Slope (%)	0.6	N/A	Gutter 2 X Slope (%)	N/A
N/A	Painted X Walk2?	Yes	N/A	DWS 2 Provided?	N/A
N/A	X Walk 2 Direction	To SE	N/A	DWS 2 Contrast?	N/A
N/A	X Walk 2 Width (In)	110.0	N/A	DWS 2 Length (In)	N/A

N/A	Road 2 Slope (%)	0.7	N/A	DWS 2 Full Width?	N/A
N/A	Road 2 X Slope (%)	2.6	N/A	DWS 2 Offset (In)	N/A
N/A	Refuge 3 Length (in)	N/A	N/A	Gutter 3 Ponding?	N/A
N/A	Refuge 3 Width (in)	N/A	N/A	Gutter 3 Lip Ht (in)	N/A
N/A	Refuge 3 Slope (%)	N/A	N/A	Gutter 3 Slope (%)	N/A
N/A	Refuge 3 XSlope (%)	N/A	N/A	Gutter 3 XSlope (%)	N/A
N/A	Painted X Walk3?	N/A	N/A	DWS 3 Provided?	N/A
N/A	X Walk 3 Direction	N/A	N/A	DWS 3 Contrast?	N/A
N/A	X Walk 3 Width (in)	N/A	N/A	DWS 3 Length (in)	N/A
N/A	Road 3 Slope (%)	N/A	N/A	DWS 3 Full Width?	N/A
N/A	Road 3 XSlope (%)	N/A	N/A	DWS 3 Offset (in)	N/A
Yes	Any Obstructions?	N/A	N/A	Storm Grate/Utility Hazard?	N/A
N/A	Obstruction Type		N/A	Storm Grate/Utility Type	
		N/A			N/A
N/A	Surface Condition	Good

Possible Solutions:

Remove & Replace Entire Refuge.
