Access Compliance Report

Public Rights-of-Way

(Island Curb Cuts)

Intersection ID: 53534	Main Street: N_JOSH_BIRMINGHAM_PY	Cross Street: WILKINSON_BV	Location: NE
ADA ID: 9DF3D080723F	Curb Cut Type: IslandRefuge3	Initial Pass/Fail: Fail	Overall Compliance: No
Codes/Mitigation Info/Possible Solution		Field Measurements/Component Compliance

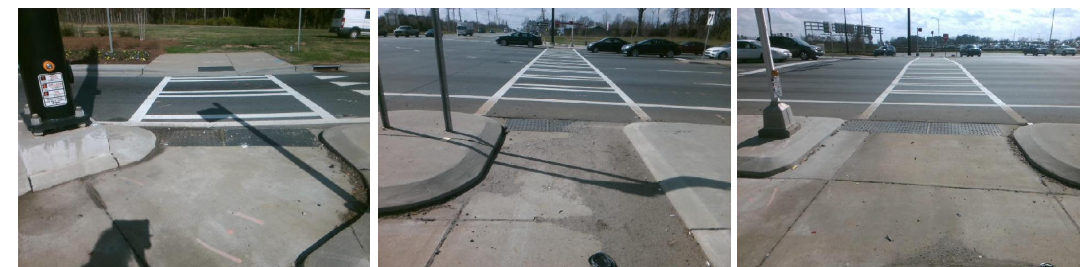
Compliance	Description	Data	Compliance	Description	Data
Yes	Refuge 1 Length (In)	69.0	N/A	Gutter 1 Ponding?	N/A
Yes	Refuge 1 Width (In)	82.0	N/A	Gutter 1 Lip Ht (In)	N/A
Yes	Refuge 1 Slope (%)	2.6	N/A	Gutter 1 Slope (%)	N/A
Yes	Refuge 1 X Slope (%)	2.3	N/A	Gutter 1 X Slope (%)	N/A
N/A	Painted X Walk1?	Yes	N/A	DWS 1 Provided?	N/A
N/A	X Walk 1 Direction	To W	N/A	DWS 1 Contrast?	N/A
N/A	X Walk 1 Width (In)	111.0	N/A	DWS 1 Length (In)	N/A
N/A	Road 1 Slope (%)	2.6	N/A	DWS 1 Full Width?	N/A
N/A	Road 1 X Slope (%)	3.8	N/A	DWS 1 Offset (In)	N/A
Yes	Refuge 2 Length (In)	110.0	N/A	Gutter 2 Ponding?	N/A
Yes	Refuge 2 Width (In)	73.0	N/A	Gutter 2 Lip Ht (In)	N/A
Yes	Refuge 2 Slope (%)	1.5	N/A	Gutter 2 Slope (%)	N/A
Yes	Refuge 2 X Slope (%)	1.0	N/A	Gutter 2 X Slope (%)	N/A
N/A	Painted X Walk2?	Yes	N/A	DWS 2 Provided?	N/A
N/A	X Walk 2 Direction	To S	N/A	DWS 2 Contrast?	N/A
N/A	X Walk 2 Width (In)	111.0	N/A	DWS 2 Length (In)	N/A

N/A	Road 2 Slope (%)	1.7	N/A	DWS 2 Full Width?	N/A
N/A	Road 2 X Slope (%)	1.7	N/A	DWS 2 Offset (In)	N/A
Yes	Refuge 3 Length (in)	92.0	N/A	Gutter 3 Ponding?	N/A
Yes	Refuge 3 Width (in)	116.0	N/A	Gutter 3 Lip Ht (in)	N/A
Yes	Refuge 3 Slope (%)	4.8	N/A	Gutter 3 Slope (%)	N/A
Yes	Refuge 3 XSlope (%)	1.0	N/A	Gutter 3 XSlope (%)	N/A
N/A	Painted X Walk3?	Yes	N/A	DWS 3 Provided?	N/A
N/A	X Walk 3 Direction	To NE	N/A	DWS 3 Contrast?	N/A
N/A	X Walk 3 Width (in)	111.0	N/A	DWS 3 Length (in)	N/A
N/A	Road 3 Slope (%)	0.4	N/A	DWS 3 Full Width?	N/A
N/A	Road 3 XSlope (%)	0.7	N/A	DWS 3 Offset (in)	N/A
Yes	Any Obstructions?	N/A	N/A	Storm Grate/Utility Hazard?	N/A
N/A	Obstruction Type		N/A	Storm Grate/Utility Type	
		N/A			N/A
N/A	Surface Condition	Good

Remove & Replace Entire Refuge.
