Access Compliance Report

Public Rights-of-Way

(Island Curb Cuts)

Intersection ID: 48168	Main Street: PERIMETER_PY	Cross Street: NORTHLAKE_MALL_DR	Location:	W
ADA ID: A1BEA67A7440	Curb Cut Type: MedianRefuge2	Initial Pass/Fail: Fail	Overall Compliance: No	Severity Score: 0
Codes/Mitigation Info/Possible Solution		Field Measurements/Component Compliance

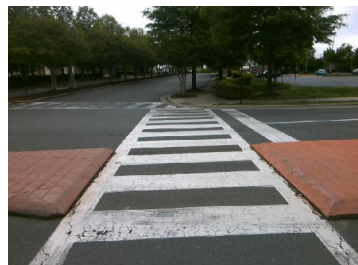
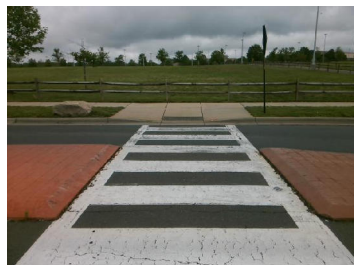
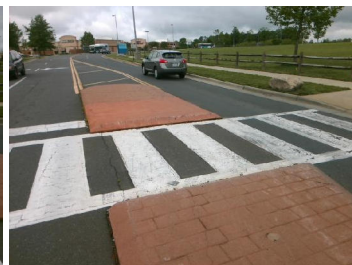
Compliance	Description	Data	Compliance	Description	Data
Yes	Refuge 1 Length (In)	55.0	N/A	Gutter 1 Ponding?	N/A
Yes	Refuge 1 Width (In)	123.0	N/A	Gutter 1 Lip Ht (In)	N/A
Yes	Refuge 1 Slope (%)	1.0	N/A	Gutter 1 Slope (%)	N/A
Yes	Refuge 1 X Slope (%)	1.9	N/A	Gutter 1 X Slope (%)	N/A
N/A	Painted X Walk1?	Yes	N/A	DWS 1 Provided?	N/A
N/A	X Walk 1 Direction	To S	N/A	DWS 1 Contrast?	N/A
N/A	X Walk 1 Width (In)	99.0	N/A	DWS 1 Length (In)	N/A
N/A	Road 1 Slope (%)	3.9	N/A	DWS 1 Full Width?	N/A
N/A	Road 1 X Slope (%)	1.2	N/A	DWS 1 Offset (In)	N/A
Yes	Refuge 2 Length (In)	55.0	N/A	Gutter 2 Ponding?	N/A
Yes	Refuge 2 Width (In)	123.0	N/A	Gutter 2 Lip Ht (In)	N/A
Yes	Refuge 2 Slope (%)	0.6	N/A	Gutter 2 Slope (%)	N/A
Yes	Refuge 2 X Slope (%)	2.1	N/A	Gutter 2 X Slope (%)	N/A
N/A	Painted X Walk2?	Yes	N/A	DWS 2 Provided?	N/A
N/A	X Walk 2 Direction	To N	N/A	DWS 2 Contrast?	N/A
N/A	X Walk 2 Width (In)	99.0	N/A	DWS 2 Length (In)	N/A

N/A	Road 2 Slope (%)	2.0	N/A	DWS 2 Full Width?	N/A
N/A	Road 2 X Slope (%)	3.1	N/A	DWS 2 Offset (In)	N/A
N/A	Refuge 3 Length (in)	N/A	N/A	Gutter 3 Ponding?	N/A
N/A	Refuge 3 Width (in)	N/A	N/A	Gutter 3 Lip Ht (in)	N/A
N/A	Refuge 3 Slope (%)	N/A	N/A	Gutter 3 Slope (%)	N/A
N/A	Refuge 3 XSlope (%)	N/A	N/A	Gutter 3 XSlope (%)	N/A
N/A	Painted X Walk3?	N/A	N/A	DWS 3 Provided?	N/A
N/A	X Walk 3 Direction	N/A	N/A	DWS 3 Contrast?	N/A
N/A	X Walk 3 Width (in)	N/A	N/A	DWS 3 Length (in)	N/A
N/A	Road 3 Slope (%)	N/A	N/A	DWS 3 Full Width?	N/A
N/A	Road 3 XSlope (%)	N/A	N/A	DWS 3 Offset (in)	N/A
Yes	Any Obstructions?	N/A	N/A	Storm Grate/Utility Hazard?	N/A
N/A	Obstruction Type		N/A	Storm Grate/Utility Type	
		N/A			N/A
N/A	Surface Condition	Good

Remove & Replace Entire Refuge.
