Access Compliance Report

Public Rights-of-Way

(Island Curb Cuts)

Intersection ID: 32449	Main Street: N_TRYON_ST	Cross Street: J_W_CLAY_BV	Location: E
ADA ID: A3B9BE5891EE	Curb Cut Type: MedianRefuge2	Initial Pass/Fail: Pass	Overall Compliance: No
Severity Score: 35.25			
Codes/Mitigation Info/Possible Solution		Field Measurements/Component Compliance

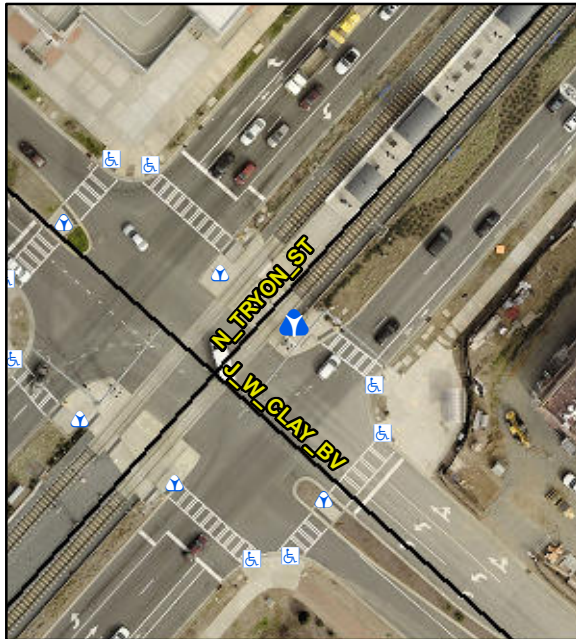
Compliance	Description	Data	Compliance	Description	Data
Yes	Refuge 1 Length (In)	105.0	Yes	Gutter 1 Ponding?	No
Yes	Refuge 1 Width (In)	120.0	Yes	Gutter 1 Lip Ht (In)	0.0
Yes	Refuge 1 Slope (%)	1.9	No	Gutter 1 Slope (%)	5.1
Yes	Refuge 1 X Slope (%)	1.0	Yes	Gutter 1 X Slope (%)	1.1
N/A	Painted X Walk1?	No	Yes	DWS 1 Provided?	Yes
N/A	X Walk 1 Direction	To NW	Yes	DWS 1 Contrast?	Yes
N/A	X Walk 1 Width (In)	N/A	Yes	DWS 1 Length (In)	24.0
N/A	Road 1 Slope (%)	1.2	Yes	DWS 1 Full Width?	Yes
N/A	Road 1 X Slope (%)	0.2	Yes	DWS 1 Offset (In)	1.0
Yes	Refuge 2 Length (In)	64.0	N/A	Gutter 2 Ponding?	No
Yes	Refuge 2 Width (In)	120.0	N/A	Gutter 2 Lip Ht (In)	N/A
Yes	Refuge 2 Slope (%)	2.1	N/A	Gutter 2 Slope (%)	N/A
Yes	Refuge 2 X Slope (%)	1.2	N/A	Gutter 2 X Slope (%)	N/A
N/A	Painted X Walk2?	No	No	DWS 2 Provided?	No
N/A	X Walk 2 Direction	To SE	N/A	DWS 2 Contrast?	No
N/A	X Walk 2 Width (In)	N/A	N/A	DWS 2 Length (In)	N/A

N/A	Road 2 Slope (%)	0.2	N/A	DWS 2 Full Width?	No
N/A	Road 2 X Slope (%)	3.0	N/A	DWS 2 Offset (In)	N/A
N/A	Refuge 3 Length (in)	N/A	N/A	Gutter 3 Ponding?	N/A
N/A	Refuge 3 Width (in)	N/A	N/A	Gutter 3 Lip Ht (in)	N/A
N/A	Refuge 3 Slope (%)	N/A	N/A	Gutter 3 Slope (%)	N/A
N/A	Refuge 3 XSlope (%)	N/A	N/A	Gutter 3 XSlope (%)	N/A
N/A	Painted X Walk3?	No	N/A	DWS 3 Provided?	N/A
N/A	X Walk 3 Direction	N/A	N/A	DWS 3 Contrast?	N/A
N/A	X Walk 3 Width (in)	N/A	N/A	DWS 3 Length (in)	N/A
N/A	Road 3 Slope (%)	N/A	N/A	DWS 3 Full Width?	N/A
N/A	Road 3 XSlope (%)	N/A	N/A	DWS 3 Offset (in)	N/A
Yes	Any Obstructions?	No	N/A	Storm Grate/Utility Hazard?	No
N/A	Obstruction Type		N/A	Storm Grate/Utility Type	
		N/A			N/A
N/A	Surface Condition	Good

**Install Detectable Warning System.
Remove & Replace Gutter.**
