Access Compliance Report

Public Rights-of-Way

(Island Curb Cuts)

Intersection ID: 43406	Main Street: ARCHDALE_DR	Cross Street: PARK_ROYAL_AV	Location: E
ADA ID: A4DFEA2177B8	Curb Cut Type: MedianRefuge2	Initial Pass/Fail: Fail	Overall Compliance: No
Codes/Mitigation Info/Possible Solution		Field Measurements/Component Compliance

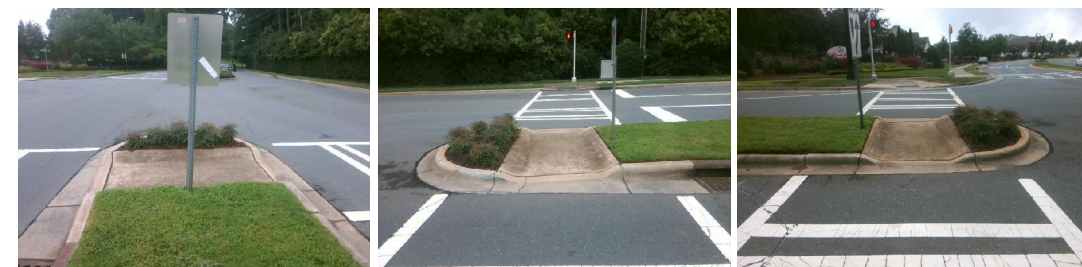
Compliance	Description	Data	Compliance	Description	Data
Yes	Refuge 1 Length (In)	50.5	N/A	Gutter 1 Ponding?	N/A
No	Refuge 1 Width (In)	44.0	N/A	Gutter 1 Lip Ht (In)	N/A
Yes	Refuge 1 Slope (%)	3.8	N/A	Gutter 1 Slope (%)	N/A
Yes	Refuge 1 X Slope (%)	0.2	N/A	Gutter 1 X Slope (%)	N/A
N/A	Painted X Walk1?	Yes	N/A	DWS 1 Provided?	N/A
N/A	X Walk 1 Direction	To S	N/A	DWS 1 Contrast?	N/A
N/A	X Walk 1 Width (In)	115.0	N/A	DWS 1 Length (In)	N/A
N/A	Road 1 Slope (%)	1.1	N/A	DWS 1 Full Width?	N/A
N/A	Road 1 X Slope (%)	2.9	N/A	DWS 1 Offset (In)	N/A
Yes	Refuge 2 Length (In)	50.5	N/A	Gutter 2 Ponding?	N/A
No	Refuge 2 Width (In)	44.0	N/A	Gutter 2 Lip Ht (In)	N/A
Yes	Refuge 2 Slope (%)	3.7	N/A	Gutter 2 Slope (%)	N/A
Yes	Refuge 2 X Slope (%)	1.4	N/A	Gutter 2 X Slope (%)	N/A
N/A	Painted X Walk2?	Yes	N/A	DWS 2 Provided?	N/A
N/A	X Walk 2 Direction	To N	N/A	DWS 2 Contrast?	N/A
N/A	X Walk 2 Width (In)	109.0	N/A	DWS 2 Length (In)	N/A

N/A	Road 2 Slope (%)	0.0	N/A	DWS 2 Full Width?	N/A
N/A	Road 2 X Slope (%)	4.4	N/A	DWS 2 Offset (In)	N/A
N/A	Refuge 3 Length (in)	N/A	N/A	Gutter 3 Ponding?	N/A
N/A	Refuge 3 Width (in)	N/A	N/A	Gutter 3 Lip Ht (in)	N/A
N/A	Refuge 3 Slope (%)	N/A	N/A	Gutter 3 Slope (%)	N/A
N/A	Refuge 3 XSlope (%)	N/A	N/A	Gutter 3 XSlope (%)	N/A
N/A	Painted X Walk3?	N/A	N/A	DWS 3 Provided?	N/A
N/A	X Walk 3 Direction	N/A	N/A	DWS 3 Contrast?	N/A
N/A	X Walk 3 Width (in)	N/A	N/A	DWS 3 Length (in)	N/A
N/A	Road 3 Slope (%)	N/A	N/A	DWS 3 Full Width?	N/A
N/A	Road 3 XSlope (%)	N/A	N/A	DWS 3 Offset (in)	N/A
Yes	Any Obstructions?	N/A	N/A	Storm Grate/Utility Hazard?	N/A
N/A	Obstruction Type		N/A	Storm Grate/Utility Type	
		N/A			N/A
N/A	Surface Condition	Good

Possible Solutions:

Remove & Replace Entire Refuge.
