# Access Compliance Report

## Public Rights-of-Way

### (Island Curb Cuts)

Intersection ID: 16587	Main Street: NORTH_FALLS_DR	Cross Street: W_TYVOLA_RD	Location: W
ADA ID: A604E0C90D82	Curb Cut Type: IslandRefuge2	Initial Pass/Fail: Fail	Overall Compliance: No
Severity Score: 25			
Codes/Mitigation Info/Possible Solution		Field Measurements/Component Compliance

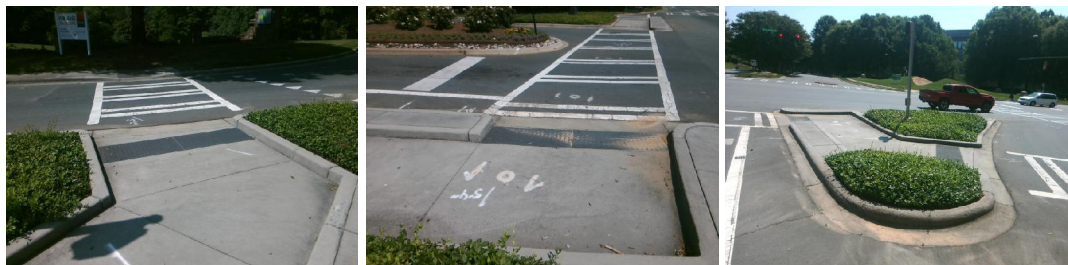
Compliance	Description	Data	Compliance	Description	Data
Yes	Refuge 1 Length (In)	84.0	N/A	Gutter 1 Ponding?	N/A
Yes	Refuge 1 Width (In)	95.0	N/A	Gutter 1 Lip Ht (In)	N/A
No	Refuge 1 Slope (%)	7.8	N/A	Gutter 1 Slope (%)	N/A
Yes	Refuge 1 X Slope (%)	3.8	N/A	Gutter 1 X Slope (%)	N/A
N/A	Painted X Walk1?	Yes	N/A	DWS 1 Provided?	N/A
N/A	X Walk 1 Direction	To S	N/A	DWS 1 Contrast?	N/A
N/A	X Walk 1 Width (In)	109.0	N/A	DWS 1 Length (In)	N/A
N/A	Road 1 Slope (%)	5.2	N/A	DWS 1 Full Width?	N/A
N/A	Road 1 X Slope (%)	0.3	N/A	DWS 1 Offset (In)	N/A
Yes	Refuge 2 Length (In)	95.0	N/A	Gutter 2 Ponding?	N/A
Yes	Refuge 2 Width (In)	185.0	N/A	Gutter 2 Lip Ht (In)	N/A
Yes	Refuge 2 Slope (%)	1.7	N/A	Gutter 2 Slope (%)	N/A
Yes	Refuge 2 X Slope (%)	3.2	N/A	Gutter 2 X Slope (%)	N/A
N/A	Painted X Walk2?	Yes	N/A	DWS 2 Provided?	N/A
N/A	X Walk 2 Direction	To N	N/A	DWS 2 Contrast?	N/A
N/A	X Walk 2 Width (In)	111.0	N/A	DWS 2 Length (In)	N/A

**Remove & Replace Entire Refuge.**
