Access Compliance Report

Public Rights-of-Way

(Island Curb Cuts)

| Intersection ID: 27490 | Main Street: BALLANTYNE_COMMONS_PY | Cross Street: JOHNSTON_RD | Location: | W |

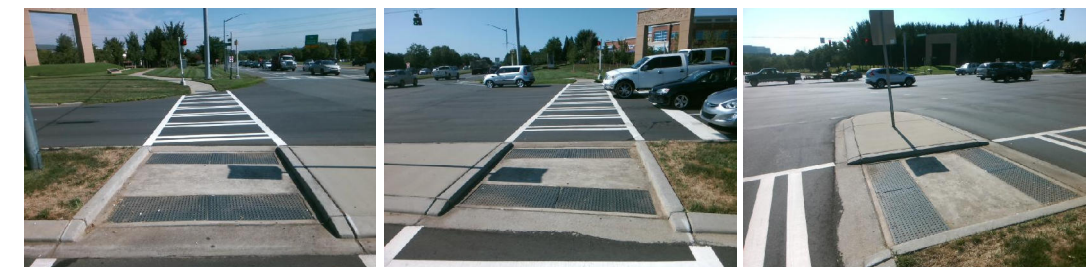
| Compliance | Description | Data | Compliance | Description | Data |
|---|---|---|---|---|---|
| Yes | Refuge 1 Slope (%) | 1.9 | No | Gutter 1 Slope (%) | 5.9 |
| N/A | Road 1 X Slope (%) | 3.4 | No | DWS 1 Offset (In) | 4.0 |

Remove & Replace Detectable Warning System. Remove & Replace Gutter.
