Access Compliance Report

Public Rights-of-Way

(Island Curb Cuts)

Intersection ID: 3559	Main Street: PERIMETER_PY	Cross Street: W_W_T_HARRIS_BV	Location: SE
ADA ID: A8675153EDC9	Curb Cut Type: IslandRefuge3	Initial Pass/Fail: Fail	Overall Compliance: No
Codes/Mitigation Info/Possible Solution		Field Measurements/Component Compliance

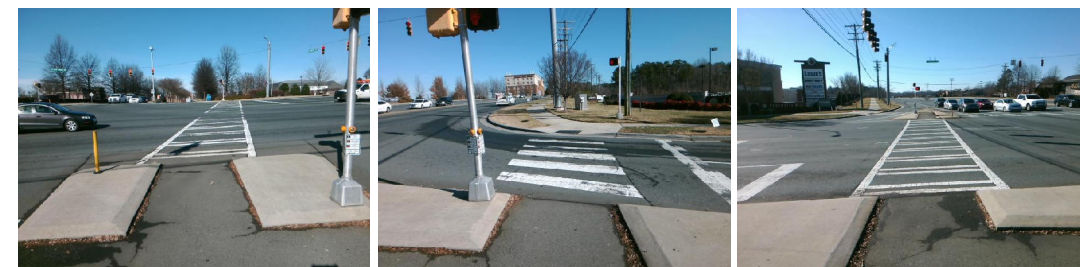
Compliance	Description	Data	Compliance	Description	Data
Yes	Refuge 1 Length (In)	133.0	N/A	Gutter 1 Ponding?	N/A
Yes	Refuge 1 Width (In)	71.0	N/A	Gutter 1 Lip Ht (In)	N/A
Yes	Refuge 1 Slope (%)	3.3	N/A	Gutter 1 Slope (%)	N/A
Yes	Refuge 1 X Slope (%)	2.1	N/A	Gutter 1 X Slope (%)	N/A
N/A	Painted X Walk1?	Yes	N/A	DWS 1 Provided?	N/A
N/A	X Walk 1 Direction	To N	N/A	DWS 1 Contrast?	N/A
N/A	X Walk 1 Width (In)	112.0	N/A	DWS 1 Length (In)	N/A
N/A	Road 1 Slope (%)	2.5	N/A	DWS 1 Full Width?	N/A
N/A	Road 1 X Slope (%)	3.7	N/A	DWS 1 Offset (In)	N/A
Yes	Refuge 2 Length (In)	67.0	N/A	Gutter 2 Ponding?	N/A
Yes	Refuge 2 Width (In)	70.0	N/A	Gutter 2 Lip Ht (In)	N/A
Yes	Refuge 2 Slope (%)	1.3	N/A	Gutter 2 Slope (%)	N/A
Yes	Refuge 2 X Slope (%)	4.7	N/A	Gutter 2 X Slope (%)	N/A
N/A	Painted X Walk2?	Yes	N/A	DWS 2 Provided?	N/A
N/A	X Walk 2 Direction	To SE	N/A	DWS 2 Contrast?	N/A
N/A	X Walk 2 Width (In)	118.0	N/A	DWS 2 Length (In)	N/A

N/A	Road 2 Slope (%)	4.4	N/A	DWS 2 Full Width?	N/A
N/A	Road 2 X Slope (%)	2.6	N/A	DWS 2 Offset (In)	N/A
Yes	Refuge 3 Length (in)	60.0	N/A	Gutter 3 Ponding?	N/A
Yes	Refuge 3 Width (in)	71.0	N/A	Gutter 3 Lip Ht (in)	N/A
Yes	Refuge 3 Slope (%)	4.6	N/A	Gutter 3 Slope (%)	N/A
Yes	Refuge 3 XSlope (%)	4.5	N/A	Gutter 3 XSlope (%)	N/A
N/A	Painted X Walk3?	Yes	N/A	DWS 3 Provided?	N/A
N/A	X Walk 3 Direction	To W	N/A	DWS 3 Contrast?	N/A
N/A	X Walk 3 Width (in)	108.0	N/A	DWS 3 Length (in)	N/A
N/A	Road 3 Slope (%)	3.4	N/A	DWS 3 Full Width?	N/A
N/A	Road 3 XSlope (%)	4.6	N/A	DWS 3 Offset (in)	N/A
Yes	Any Obstructions?	N/A	N/A	Storm Grate/Utility Hazard?	N/A
N/A	Obstruction Type		N/A	Storm Grate/Utility Type	
		N/A			N/A
N/A	Surface Condition	Good

Remove & Replace Entire Refuge.
