Access Compliance Report

Public Rights-of-Way

(Island Curb Cuts)

| Intersection ID: 28389 | Main Street: ARDREY_KELL_RD | Cross Street: LANCASTER_HY | Location: SW |

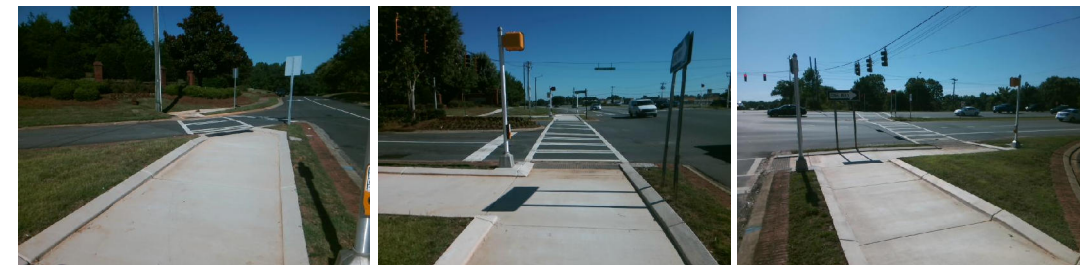
| ADA ID: AB357F0E0B91 | Curb Cut Type: IslandRefuge3 | Initial Pass/Fail: Fail | Overall Compliance: No |

Remove & Replace Entire Refuge.
