Access Compliance Report

Public Rights-of-Way

(Island Curb Cuts)

Intersection ID: 14091	Main Street: E_7TH_ST	Cross Street: N_CASWELL_RD	Location: NW
ADA ID: AB9689C72EBF	Curb Cut Type: MedianRefuge2	Initial Pass/Fail: Fail	Overall Compliance: No
Severity Score: 12.5			
Codes/Mitigation Info/Possible Solution		Field Measurements/Component Compliance

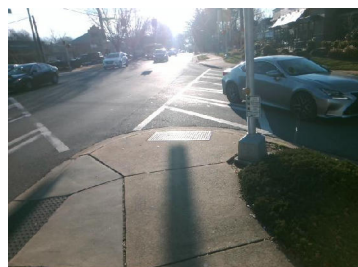
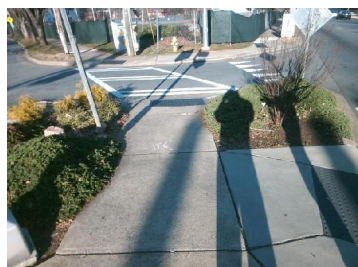
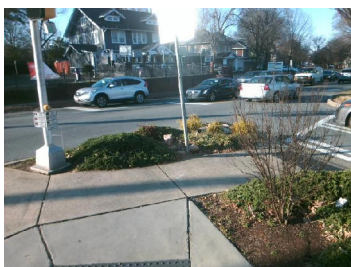
**#3 WAS COLLECTED SEPARATELY
AS PERPENDICULAR RAMP**

Compliance	Description	Data	Compliance	Description	Data
Yes	Refuge 1 Length (In)	135.0	N/A	Gutter 1 Ponding?	N/A
Yes	Refuge 1 Width (In)	60.0	N/A	Gutter 1 Lip Ht (In)	N/A
Yes	Refuge 1 Slope (%)	2.8	N/A	Gutter 1 Slope (%)	N/A
Yes	Refuge 1 X Slope (%)	0.8	N/A	Gutter 1 X Slope (%)	N/A
N/A	Painted X Walk1?	Yes	N/A	DWS 1 Provided?	N/A
N/A	X Walk 1 Direction	To SE	N/A	DWS 1 Contrast?	N/A
N/A	X Walk 1 Width (In)	120.0	N/A	DWS 1 Length (In)	N/A
N/A	Road 1 Slope (%)	1.0	N/A	DWS 1 Full Width?	N/A
N/A	Road 1 X Slope (%)	1.2	N/A	DWS 1 Offset (In)	N/A
Yes	Refuge 2 Length (In)	135.0	N/A	Gutter 2 Ponding?	N/A
Yes	Refuge 2 Width (In)	60.0	N/A	Gutter 2 Lip Ht (In)	N/A
No	Refuge 2 Slope (%)	6.0	N/A	Gutter 2 Slope (%)	N/A
Yes	Refuge 2 X Slope (%)	4.0	N/A	Gutter 2 X Slope (%)	N/A
N/A	Painted X Walk2?	Yes	N/A	DWS 2 Provided?	N/A
N/A	X Walk 2 Direction	To NW	N/A	DWS 2 Contrast?	N/A
N/A	X Walk 2 Width (In)	102.0	N/A	DWS 2 Length (In)	N/A

N/A	Road 2 Slope (%)	0.7	N/A	DWS 2 Full Width?	N/A
N/A	Road 2 X Slope (%)	2.2	N/A	DWS 2 Offset (In)	N/A
N/A	Refuge 3 Length (in)	N/A	N/A	Gutter 3 Ponding?	N/A
N/A	Refuge 3 Width (in)	N/A	N/A	Gutter 3 Lip Ht (in)	N/A
N/A	Refuge 3 Slope (%)	N/A	N/A	Gutter 3 Slope (%)	N/A
N/A	Refuge 3 XSlope (%)	N/A	N/A	Gutter 3 XSlope (%)	N/A
N/A	Painted X Walk3?	N/A	N/A	DWS 3 Provided?	N/A
N/A	X Walk 3 Direction	N/A	N/A	DWS 3 Contrast?	N/A
N/A	X Walk 3 Width (in)	N/A	N/A	DWS 3 Length (in)	N/A
N/A	Road 3 Slope (%)	N/A	N/A	DWS 3 Full Width?	N/A
N/A	Road 3 XSlope (%)	N/A	N/A	DWS 3 Offset (in)	N/A
Yes	Any Obstructions?	N/A	N/A	Storm Grate/Utility Hazard?	N/A
N/A	Obstruction Type		N/A	Storm Grate/Utility Type	
		N/A			N/A
N/A	Surface Condition	Good

Remove & Replace Entire Refuge.
