# Access Compliance Report

## Public Rights-of-Way

### (Island Curb Cuts)

Intersection ID: 8739	Main Street: N_TRYON_ST	Cross Street: W_EASTWAY_DR	Location:	SW
ADA ID: AC14DFA9C5CF	Curb Cut Type: IslandRefuge2	Initial Pass/Fail: Pass	Overall Compliance: No	Severity Score: 7.5
Codes/Mitigation Info/Possible Solution		Field Measurements/Component Compliance

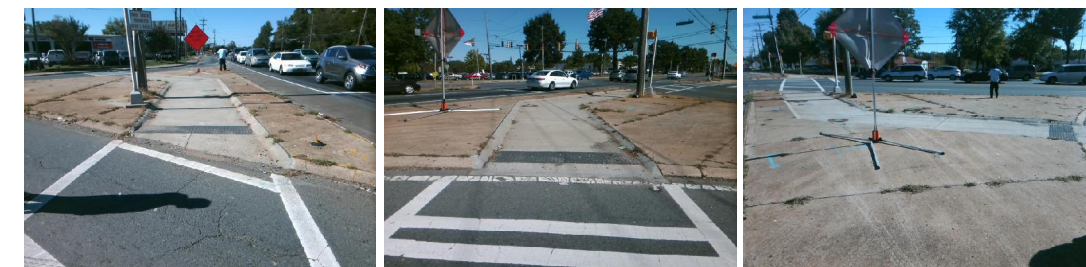
Compliance	Description	Data	Compliance	Description	Data
Yes	Refuge 1 Length (In)	363.5	Yes	Gutter 1 Ponding?	No
Yes	Refuge 1 Width (In)	92.0	No	Gutter 1 Lip Ht (In)	0.5
Yes	Refuge 1 Slope (%)	0.9	Yes	Gutter 1 Slope (%)	0.0
Yes	Refuge 1 X Slope (%)	1.1	Yes	Gutter 1 X Slope (%)	0.7
N/A	Painted X Walk1?	Yes	Yes	DWS 1 Provided?	Yes
N/A	X Walk 1 Direction	To NE	Yes	DWS 1 Contrast?	Yes
N/A	X Walk 1 Width (In)	104.5	Yes	DWS 1 Length (In)	24.0
N/A	Road 1 Slope (%)	1.3	Yes	DWS 1 Full Width?	Yes
N/A	Road 1 X Slope (%)	1.5	Yes	DWS 1 Offset (In)	0.0
Yes	Refuge 2 Length (In)	280.0	Yes	Gutter 2 Ponding?	No
Yes	Refuge 2 Width (In)	91.5	Yes	Gutter 2 Lip Ht (In)	0.0
Yes	Refuge 2 Slope (%)	1.3	Yes	Gutter 2 Slope (%)	2.4
Yes	Refuge 2 X Slope (%)	1.4	Yes	Gutter 2 X Slope (%)	3.4
N/A	Painted X Walk2?	Yes	Yes	DWS 2 Provided?	Yes
N/A	X Walk 2 Direction	To SW	Yes	DWS 2 Contrast?	Yes
N/A	X Walk 2 Width (In)	109.0	Yes	DWS 2 Length (In)	24.0

N/A	Road 2 Slope (%)	2.5	Yes	DWS 2 Full Width?	Yes
N/A	Road 2 X Slope (%)	0.5	Yes	DWS 2 Offset (In)	0.0
N/A	Refuge 3 Length (in)	N/A	N/A	Gutter 3 Ponding?	N/A
N/A	Refuge 3 Width (in)	N/A	N/A	Gutter 3 Lip Ht (in)	N/A
N/A	Refuge 3 Slope (%)	N/A	N/A	Gutter 3 Slope (%)	N/A
N/A	Refuge 3 XSlope (%)	N/A	N/A	Gutter 3 XSlope (%)	N/A
N/A	Painted X Walk3?	N/A	N/A	DWS 3 Provided?	N/A
N/A	X Walk 3 Direction	N/A	N/A	DWS 3 Contrast?	N/A
N/A	X Walk 3 Width (in)	N/A	N/A	DWS 3 Length (in)	N/A
N/A	Road 3 Slope (%)	N/A	N/A	DWS 3 Full Width?	N/A
N/A	Road 3 XSlope (%)	N/A	N/A	DWS 3 Offset (in)	N/A
Yes	Any Obstructions?	No	N/A	Storm Grate/Utility Hazard?	Yes
N/A	Obstruction Type	N/A	N/A	Storm Grate/Utility Type	
N/A	Surface Condition	Good	N/A	R1 WTR VAL/MANHOLE, R2 MANHOLE

**Grind Gutter Lip. Utility Present.**
