Access Compliance Report

Public Rights-of-Way

(Island Curb Cuts)

Intersection ID: 14267	Main Street: CLANTON_RD	Cross Street: FARMER_ST	Location: N
ADA ID: B0AF5CEE9956	Curb Cut Type: MedianRefuge2	Initial Pass/Fail: Fail	Overall Compliance: No
Severity Score: 0			
Codes/Mitigation Info/Possible Solution		Field Measurements/Component Compliance

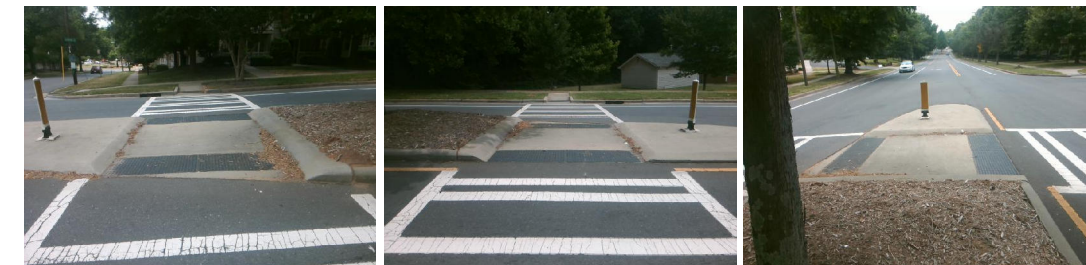
Compliance	Description	Data	Compliance	Description	Data
Yes	Refuge 1 Length (In)	64.0	N/A	Gutter 1 Ponding?	N/A
Yes	Refuge 1 Width (In)	99.0	N/A	Gutter 1 Lip Ht (In)	N/A
Yes	Refuge 1 Slope (%)	0.8	N/A	Gutter 1 Slope (%)	N/A
Yes	Refuge 1 X Slope (%)	3.8	N/A	Gutter 1 X Slope (%)	N/A
N/A	Painted X Walk1?	Yes	N/A	DWS 1 Provided?	N/A
N/A	X Walk 1 Direction	To E	N/A	DWS 1 Contrast?	N/A
N/A	X Walk 1 Width (In)	116.0	N/A	DWS 1 Length (In)	N/A
N/A	Road 1 Slope (%)	4.7	N/A	DWS 1 Full Width?	N/A
N/A	Road 1 X Slope (%)	3.2	N/A	DWS 1 Offset (In)	N/A
Yes	Refuge 2 Length (In)	64.0	N/A	Gutter 2 Ponding?	N/A
Yes	Refuge 2 Width (In)	99.0	N/A	Gutter 2 Lip Ht (In)	N/A
Yes	Refuge 2 Slope (%)	1.0	N/A	Gutter 2 Slope (%)	N/A
Yes	Refuge 2 X Slope (%)	5.0	N/A	Gutter 2 X Slope (%)	N/A
N/A	Painted X Walk2?	Yes	N/A	DWS 2 Provided?	N/A
N/A	X Walk 2 Direction	To W	N/A	DWS 2 Contrast?	N/A
N/A	X Walk 2 Width (In)	118.0	N/A	DWS 2 Length (In)	N/A

N/A	Road 2 Slope (%)	5.2	N/A	DWS 2 Full Width?	N/A
N/A	Road 2 X Slope (%)	3.1	N/A	DWS 2 Offset (In)	N/A
N/A	Refuge 3 Length (in)	N/A	N/A	Gutter 3 Ponding?	N/A
N/A	Refuge 3 Width (in)	N/A	N/A	Gutter 3 Lip Ht (in)	N/A
N/A	Refuge 3 Slope (%)	N/A	N/A	Gutter 3 Slope (%)	N/A
N/A	Refuge 3 XSlope (%)	N/A	N/A	Gutter 3 XSlope (%)	N/A
N/A	Painted X Walk3?	N/A	N/A	DWS 3 Provided?	N/A
N/A	X Walk 3 Direction	N/A	N/A	DWS 3 Contrast?	N/A
N/A	X Walk 3 Width (in)	N/A	N/A	DWS 3 Length (in)	N/A
N/A	Road 3 Slope (%)	N/A	N/A	DWS 3 Full Width?	N/A
N/A	Road 3 XSlope (%)	N/A	N/A	DWS 3 Offset (in)	N/A
Yes	Any Obstructions?	N/A	N/A	Storm Grate/Utility Hazard?	N/A
N/A	Obstruction Type		N/A	Storm Grate/Utility Type	
		N/A			N/A
N/A	Surface Condition	Good

Possible Solutions:

Remove & Replace Entire Refuge.
