Access Compliance Report

Public Rights-of-Way

(Island Curb Cuts)

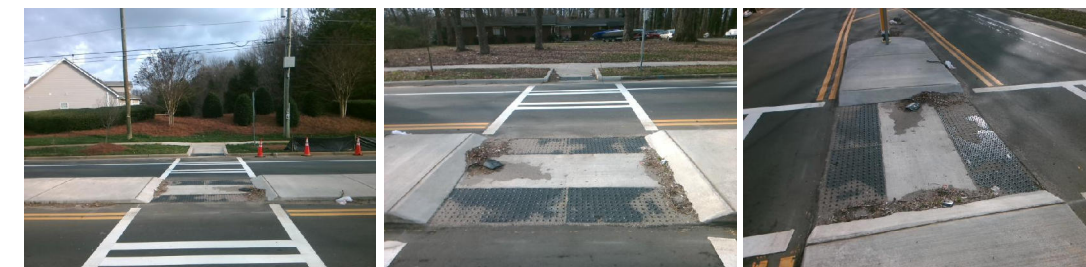
Intersection ID: 10038034	Main Street: SHOPTON_RD_WEST	Cross Street: N/A	Location: E
ADA ID: B1DB2C2221A5	Curb Cut Type: MedianRefuge2	Initial Pass/Fail: Fail	Overall Compliance: No
Codes/Mitigation Info/Possible Solution		Field Measurements/Component Compliance	
Severity Score: 0

Compliance	Description	Data	Compliance	Description	Data
Yes	Refuge 1 Length (In)	42.0	N/A	Gutter 1 Ponding?	N/A
Yes	Refuge 1 Width (In)	102.0	N/A	Gutter 1 Lip Ht (In)	N/A
Yes	Refuge 1 Slope (%)	1.3	N/A	Gutter 1 Slope (%)	N/A
Yes	Refuge 1 X Slope (%)	0.8	N/A	Gutter 1 X Slope (%)	N/A
N/A	Painted X Walk1?	Yes	N/A	DWS 1 Provided?	N/A
N/A	X Walk 1 Direction	To N	N/A	DWS 1 Contrast?	N/A
N/A	X Walk 1 Width (In)	103.0	N/A	DWS 1 Length (In)	N/A
N/A	Road 1 Slope (%)	0.2	N/A	DWS 1 Full Width?	N/A
N/A	Road 1 X Slope (%)	3.7	N/A	DWS 1 Offset (In)	N/A
Yes	Refuge 2 Length (In)	42.0	N/A	Gutter 2 Ponding?	N/A
Yes	Refuge 2 Width (In)	102.0	N/A	Gutter 2 Lip Ht (In)	N/A
Yes	Refuge 2 Slope (%)	0.7	N/A	Gutter 2 Slope (%)	N/A
Yes	Refuge 2 X Slope (%)	2.1	N/A	Gutter 2 X Slope (%)	N/A
N/A	Painted X Walk2?	Yes	N/A	DWS 2 Provided?	N/A
N/A	X Walk 2 Direction	To S	N/A	DWS 2 Contrast?	N/A
N/A	X Walk 2 Width (In)	105.0	N/A	DWS 2 Length (In)	N/A

N/A	Road 2 Slope (%)	1.9	N/A	DWS 2 Full Width?	N/A
N/A	Road 2 X Slope (%)	0.2	N/A	DWS 2 Offset (In)	N/A
N/A	Refuge 3 Length (in)	N/A	N/A	Gutter 3 Ponding?	N/A
N/A	Refuge 3 Width (in)	N/A	N/A	Gutter 3 Lip Ht (in)	N/A
N/A	Refuge 3 Slope (%)	N/A	N/A	Gutter 3 Slope (%)	N/A
N/A	Refuge 3 XSlope (%)	N/A	N/A	Gutter 3 XSlope (%)	N/A
N/A	Painted X Walk3?	N/A	N/A	DWS 3 Provided?	N/A
N/A	X Walk 3 Direction	N/A	N/A	DWS 3 Contrast?	N/A
N/A	X Walk 3 Width (in)	N/A	N/A	DWS 3 Length (in)	N/A
N/A	Road 3 Slope (%)	N/A	N/A	DWS 3 Full Width?	N/A
N/A	Road 3 XSlope (%)	N/A	N/A	DWS 3 Offset (in)	N/A
Yes	Any Obstructions?	N/A	N/A	Storm Grate/Utility Hazard?	N/A
N/A	Obstruction Type		N/A	Storm Grate/Utility Type	
		N/A			N/A
N/A	Surface Condition	Good

Remove & Replace Entire Refuge.
