# Access Compliance Report

## Public Rights-of-Way

### (Island Curb Cuts)

| Intersection ID: 12640 | Main Street: W_MOREHEAD_ST | Cross Street: WILKINSON_BV | Location: NW |

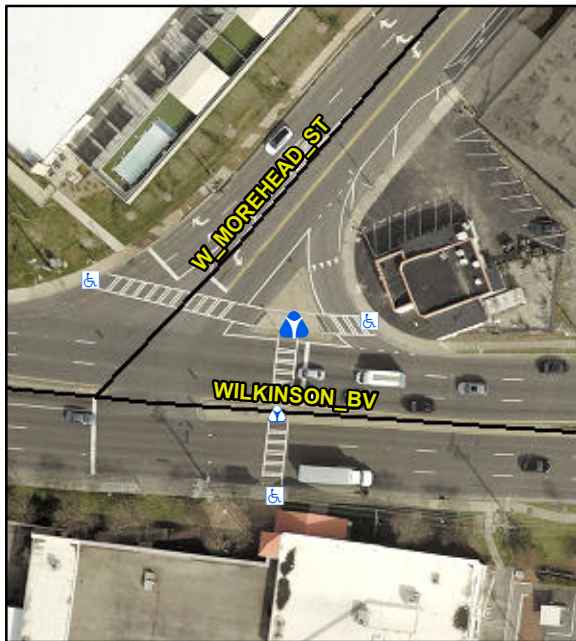
| ADA ID: B2480069C652 | Curb Cut Type: IslandRefuge3 | Initial Pass/Fail: Pass | Overall Compliance: No |
| Severity Score: 5.25 | | | |

**Remove & Replace Detectable Warning System.**
