Access Compliance Report

Public Rights-of-Way

(Island Curb Cuts)

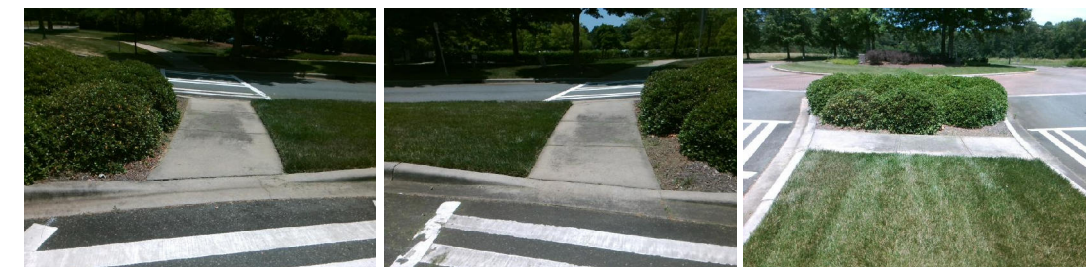
Intersection ID: 10027256	Main Street: GLEN_LAKE_DR	Cross Street: N/A	Location: S
ADA ID: B38383AF1725	Curb Cut Type: MedianRefuge2	Initial Pass/Fail: Fail	Overall Compliance: No
Severity Score: 1.25			
Codes/Mitigation Info/Possible Solution		Field Measurements/Component Compliance

Compliance	Description	Data	Compliance	Description	Data
Yes	Refuge 1 Length (In)	79.5	N/A	Gutter 1 Ponding?	N/A
Yes	Refuge 1 Width (In)	60.0	N/A	Gutter 1 Lip Ht (In)	N/A
Yes	Refuge 1 Slope (%)	4.8	N/A	Gutter 1 Slope (%)	N/A
Yes	Refuge 1 X Slope (%)	1.4	N/A	Gutter 1 X Slope (%)	N/A
N/A	Painted X Walk1?	Yes	N/A	DWS 1 Provided?	N/A
N/A	X Walk 1 Direction	To W	N/A	DWS 1 Contrast?	N/A
N/A	X Walk 1 Width (In)	104.0	N/A	DWS 1 Length (In)	N/A
N/A	Road 1 Slope (%)	3.3	N/A	DWS 1 Full Width?	N/A
N/A	Road 1 X Slope (%)	2.6	N/A	DWS 1 Offset (In)	N/A
Yes	Refuge 2 Length (In)	79.5	N/A	Gutter 2 Ponding?	N/A
Yes	Refuge 2 Width (In)	60.0	N/A	Gutter 2 Lip Ht (In)	N/A
Yes	Refuge 2 Slope (%)	0.4	N/A	Gutter 2 Slope (%)	N/A
Yes	Refuge 2 X Slope (%)	2.3	N/A	Gutter 2 X Slope (%)	N/A
N/A	Painted X Walk2?	Yes	N/A	DWS 2 Provided?	N/A
N/A	X Walk 2 Direction	To E	N/A	DWS 2 Contrast?	N/A
N/A	X Walk 2 Width (In)	104.0	N/A	DWS 2 Length (In)	N/A

N/A	Road 2 Slope (%)	3.1	N/A	DWS 2 Full Width?	N/A
N/A	Road 2 X Slope (%)	0.2	N/A	DWS 2 Offset (In)	N/A
N/A	Refuge 3 Length (in)	N/A	N/A	Gutter 3 Ponding?	N/A
N/A	Refuge 3 Width (in)	N/A	N/A	Gutter 3 Lip Ht (in)	N/A
N/A	Refuge 3 Slope (%)	N/A	N/A	Gutter 3 Slope (%)	N/A
N/A	Refuge 3 XSlope (%)	N/A	N/A	Gutter 3 XSlope (%)	N/A
N/A	Painted X Walk3?	N/A	N/A	DWS 3 Provided?	N/A
N/A	X Walk 3 Direction	N/A	N/A	DWS 3 Contrast?	N/A
N/A	X Walk 3 Width (in)	N/A	N/A	DWS 3 Length (in)	N/A
N/A	Road 3 Slope (%)	N/A	N/A	DWS 3 Full Width?	N/A
N/A	Road 3 XSlope (%)	N/A	N/A	DWS 3 Offset (in)	N/A
Yes	Any Obstructions?	N/A	N/A	Storm Grate/Utility Hazard?	N/A
N/A	Obstruction Type		N/A	Storm Grate/Utility Type	
		N/A			N/A
N/A	Surface Condition	Good

Remove & Replace Entire Refuge.
