Access Compliance Report

Public Rights-of-Way

(Island Curb Cuts)

Intersection ID: 12151	Main Street: W_MOREHEAD_ST	Cross Street: MILLERTON_AV	Location: S
ADA ID: B4C5268AF7D8	Curb Cut Type: MedianRefuge2	Initial Pass/Fail: Pass	Overall Compliance: Yes
Codes/Mitigation Info/Possible Solution		Field Measurements/Component Compliance	
Severity Score: 0.25

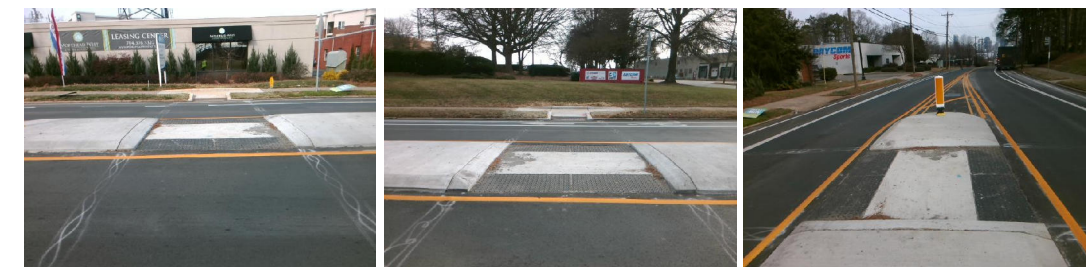
Compliance	Description	Data	Compliance	Description	Data
Yes	Refuge 1 Length (In)	49.0	Yes	Gutter 1 Ponding?	No
Yes	Refuge 1 Width (In)	98.0	Yes	Gutter 1 Lip Ht (In)	0.0
Yes	Refuge 1 Slope (%)	3.0	Yes	Gutter 1 Slope (%)	1.0
Yes	Refuge 1 X Slope (%)	0.7	Yes	Gutter 1 X Slope (%)	0.7
N/A	Painted X Walk1?	No	Yes	DWS 1 Provided?	Yes
N/A	X Walk 1 Direction	To N	Yes	DWS 1 Contrast?	Yes
N/A	X Walk 1 Width (In)	N/A	Yes	DWS 1 Length (In)	24.0
N/A	Road 1 Slope (%)	1.1	Yes	DWS 1 Full Width?	Yes
N/A	Road 1 X Slope (%)	3.5	Yes	DWS 1 Offset (In)	0.0
Yes	Refuge 2 Length (In)	49.0	Yes	Gutter 2 Ponding?	No
Yes	Refuge 2 Width (In)	98.0	Yes	Gutter 2 Lip Ht (In)	0.0
Yes	Refuge 2 Slope (%)	3.4	Yes	Gutter 2 Slope (%)	0.1
Yes	Refuge 2 X Slope (%)	1.2	Yes	Gutter 2 X Slope (%)	0.1
N/A	Painted X Walk2?	No	Yes	DWS 2 Provided?	Yes
N/A	X Walk 2 Direction	To S	Yes	DWS 2 Contrast?	Yes
N/A	X Walk 2 Width (In)	N/A	Yes	DWS 2 Length (In)	24.0

N/A	Road 2 Slope (%)	1.0	Yes	DWS 2 Full Width?	Yes
N/A	Road 2 X Slope (%)	3.5	Yes	DWS 2 Offset (In)	0.0
N/A	Refuge 3 Length (in)	N/A	N/A	Gutter 3 Ponding?	N/A
N/A	Refuge 3 Width (in)	N/A	N/A	Gutter 3 Lip Ht (in)	N/A
N/A	Refuge 3 Slope (%)	N/A	N/A	Gutter 3 Slope (%)	N/A
N/A	Refuge 3 XSlope (%)	N/A	N/A	Gutter 3 XSlope (%)	N/A
N/A	Painted X Walk3?	N/A	N/A	DWS 3 Provided?	N/A
N/A	X Walk 3 Direction	N/A	N/A	DWS 3 Contrast?	N/A
N/A	X Walk 3 Width (in)	N/A	N/A	DWS 3 Length (in)	N/A
N/A	Road 3 Slope (%)	N/A	N/A	DWS 3 Full Width?	N/A
N/A	Road 3 XSlope (%)	N/A	N/A	DWS 3 Offset (in)	N/A
Yes	Any Obstructions?	No	N/A	Storm Grate/Utility Hazard?	No
N/A	Obstruction Type		N/A	Storm Grate/Utility Type	
		N/A			N/A
N/A	Surface Condition	Good
