Access Compliance Report

Public Rights-of-Way

(Island Curb Cuts)

| Intersection ID: 50762 | Main Street: SCOTT_CREEK_DR | Cross Street: BACK_CREEK_CHURCH_RD | Location: E |

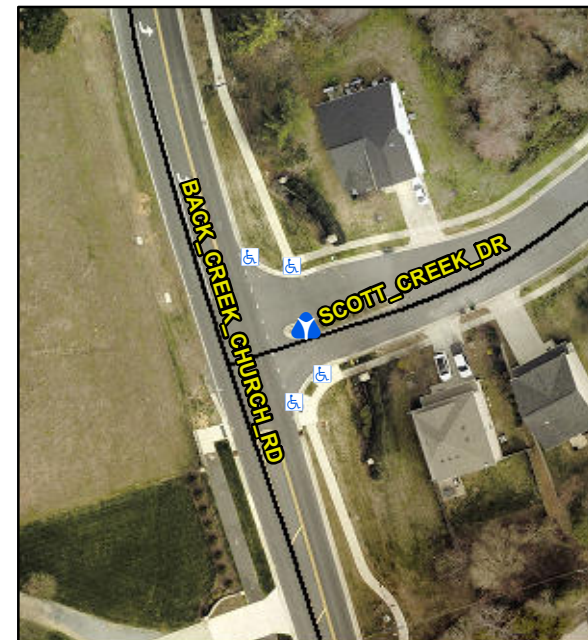
| ADA ID: B6490744228D | Curb Cut Type: MedianRefuge2 | Initial Pass/Fail: Fail | Overall Compliance: No |

| Compliance | Description | Data | Compliance | Description | Data |
|---|---|---|---|---|---|
| No | Refuge 1 Width (In) | 47.5 | No | Gutter 1 Lip Ht (In) | 0.75 |
| No | Refuge 2 Width (In) | 47.5 | No | Gutter 2 Lip Ht (In) | 0.75 |

Remove & Replace Entire Refuge.
Remove & Replace Gutter.
