# Access Compliance Report

## Public Rights-of-Way

### (Island Curb Cuts)

Intersection ID: 10025682	Main Street: EAST_BV	Cross Street: N/A	Location: N
ADA ID: B6A9C05870B7	Curb Cut Type: MedianRefuge2	Initial Pass/Fail: Fail	Overall Compliance: No
Severity Score: 12.5			
Codes/Mitigation Info/Possible Solution		Field Measurements/Component Compliance

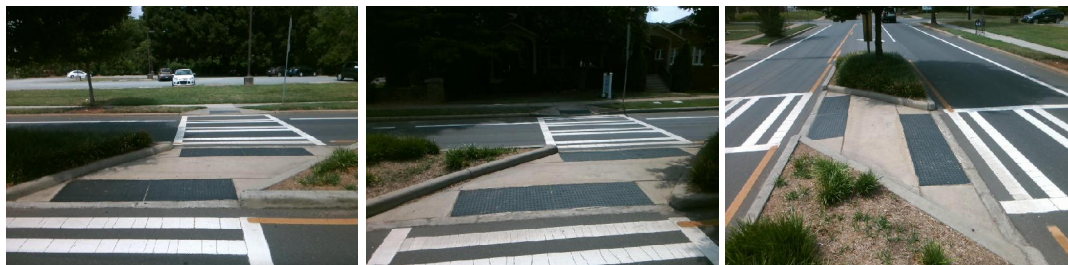
Compliance	Description	Data	Compliance	Description	Data
Yes	Refuge 1 Length (In)	44.25	N/A	Gutter 1 Ponding?	N/A
Yes	Refuge 1 Width (In)	124.0	N/A	Gutter 1 Lip Ht (In)	N/A
No	Refuge 1 Slope (%)	5.2	N/A	Gutter 1 Slope (%)	N/A
Yes	Refuge 1 X Slope (%)	0.8	N/A	Gutter 1 X Slope (%)	N/A
N/A	Painted X Walk1?	Yes	N/A	DWS 1 Provided?	N/A
N/A	X Walk 1 Direction	To SW	N/A	DWS 1 Contrast?	N/A
N/A	X Walk 1 Width (In)	110.0	N/A	DWS 1 Length (In)	N/A
N/A	Road 1 Slope (%)	1.1	N/A	DWS 1 Full Width?	N/A
N/A	Road 1 X Slope (%)	2.4	N/A	DWS 1 Offset (In)	N/A
Yes	Refuge 2 Length (In)	44.25	N/A	Gutter 2 Ponding?	N/A
Yes	Refuge 2 Width (In)	124.0	N/A	Gutter 2 Lip Ht (In)	N/A
No	Refuge 2 Slope (%)	6.1	N/A	Gutter 2 Slope (%)	N/A
Yes	Refuge 2 X Slope (%)	0.4	N/A	Gutter 2 X Slope (%)	N/A
N/A	Painted X Walk2?	Yes	N/A	DWS 2 Provided?	N/A
N/A	X Walk 2 Direction	To NE	N/A	DWS 2 Contrast?	N/A
N/A	X Walk 2 Width (In)	112.0	N/A	DWS 2 Length (In)	N/A

N/A	Road 2 Slope (%)	0.6	N/A	DWS 2 Full Width?	N/A
N/A	Road 2 X Slope (%)	1.2	N/A	DWS 2 Offset (In)	N/A
N/A	Refuge 3 Length (in)	N/A	N/A	Gutter 3 Ponding?	N/A
N/A	Refuge 3 Width (in)	N/A	N/A	Gutter 3 Lip Ht (in)	N/A
N/A	Refuge 3 Slope (%)	N/A	N/A	Gutter 3 Slope (%)	N/A
N/A	Refuge 3 XSlope (%)	N/A	N/A	Gutter 3 XSlope (%)	N/A
N/A	Painted X Walk3?	N/A	N/A	DWS 3 Provided?	N/A
N/A	X Walk 3 Direction	N/A	N/A	DWS 3 Contrast?	N/A
N/A	X Walk 3 Width (in)	N/A	N/A	DWS 3 Length (in)	N/A
N/A	Road 3 Slope (%)	N/A	N/A	DWS 3 Full Width?	N/A
N/A	Road 3 XSlope (%)	N/A	N/A	DWS 3 Offset (in)	N/A
Yes	Any Obstructions?	N/A	N/A	Storm Grate/Utility Hazard?	N/A
N/A	Obstruction Type		N/A	Storm Grate/Utility Type	
			N/A		N/A
N/A	Surface Condition	Good

Possible Solutions:

**Remove & Replace Entire Refuge.**
