Access Compliance Report

Public Rights-of-Way

(Island Curb Cuts)

Intersection ID: 10036062	Main Street: RIVERGATE_PY	Cross Street: N/A	Location: NW
ADA ID: B782F7C39E78	Curb Cut Type: MedianRefuge2	Initial Pass/Fail: Fail	Overall Compliance: No
Codes/Mitigation Info/Possible Solution		Field Measurements/Component Compliance

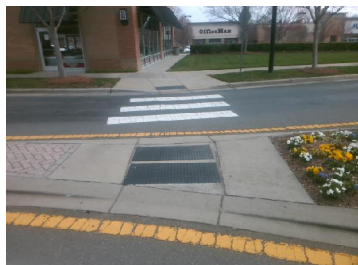
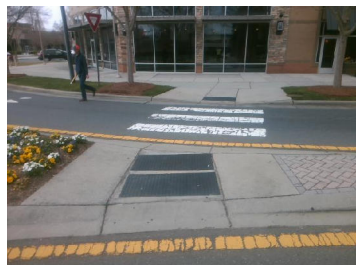
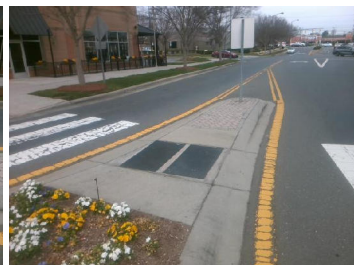
Compliance	Description	Data	Compliance	Description	Data
No	Refuge 1 Length (In)	28.0	N/A	Gutter 1 Ponding?	N/A
No	Refuge 1 Width (In)	51.0	N/A	Gutter 1 Lip Ht (In)	N/A
Yes	Refuge 1 Slope (%)	1.0	N/A	Gutter 1 Slope (%)	N/A
Yes	Refuge 1 X Slope (%)	2.4	N/A	Gutter 1 X Slope (%)	N/A
N/A	Painted X Walk1?	Yes	N/A	DWS 1 Provided?	N/A
N/A	X Walk 1 Direction	To NE	N/A	DWS 1 Contrast?	N/A
N/A	X Walk 1 Width (In)	120.0	N/A	DWS 1 Length (In)	N/A
N/A	Road 1 Slope (%)	1.1	N/A	DWS 1 Full Width?	N/A
N/A	Road 1 X Slope (%)	1.4	N/A	DWS 1 Offset (In)	N/A
No	Refuge 2 Length (In)	28.0	N/A	Gutter 2 Ponding?	N/A
No	Refuge 2 Width (In)	51.0	N/A	Gutter 2 Lip Ht (In)	N/A
Yes	Refuge 2 Slope (%)	2.3	N/A	Gutter 2 Slope (%)	N/A
Yes	Refuge 2 X Slope (%)	1.8	N/A	Gutter 2 X Slope (%)	N/A
N/A	Painted X Walk2?	Yes	N/A	DWS 2 Provided?	N/A
N/A	X Walk 2 Direction	To SW	N/A	DWS 2 Contrast?	N/A
N/A	X Walk 2 Width (In)	120.0	N/A	DWS 2 Length (In)	N/A

Remove & Replace Entire Refuge.
