# Access Compliance Report

## Public Rights-of-Way

### (Island Curb Cuts)

Intersection ID: 18567	Main Street: MICHAEL_BAKER_PL	Cross Street: RUNNYMEDE_LN	Location: E
ADA ID: B8F41101EE0A	Curb Cut Type: MedianRefuge2	Initial Pass/Fail: Fail	Overall Compliance: No
Codes/Mitigation Info/Possible Solution		Field Measurements/Component Compliance

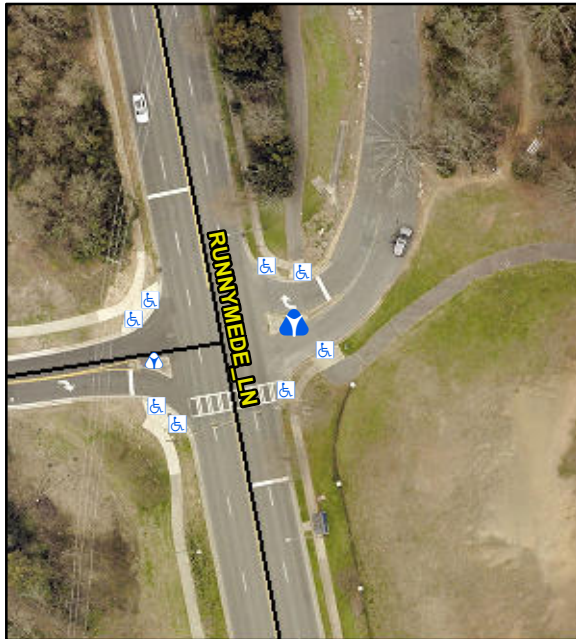
Compliance	Description	Data	Compliance	Description	Data
No	Refuge 1 Length (In)	24.0	N/A	Gutter 1 Ponding?	N/A
Yes	Refuge 1 Width (In)	74.0	N/A	Gutter 1 Lip Ht (In)	N/A
Yes	Refuge 1 Slope (%)	1.4	N/A	Gutter 1 Slope (%)	N/A
No	Refuge 1 X Slope (%)	6.8	N/A	Gutter 1 X Slope (%)	N/A
N/A	Painted X Walk1?	No	N/A	DWS 1 Provided?	N/A
N/A	X Walk 1 Direction	To S	N/A	DWS 1 Contrast?	N/A
N/A	X Walk 1 Width (In)	N/A	N/A	DWS 1 Length (In)	N/A
N/A	Road 1 Slope (%)	5.5	N/A	DWS 1 Full Width?	N/A
N/A	Road 1 X Slope (%)	3.1	N/A	DWS 1 Offset (In)	N/A
No	Refuge 2 Length (In)	24.0	N/A	Gutter 2 Ponding?	N/A
Yes	Refuge 2 Width (In)	74.0	N/A	Gutter 2 Lip Ht (In)	N/A
Yes	Refuge 2 Slope (%)	1.1	N/A	Gutter 2 Slope (%)	N/A
No	Refuge 2 X Slope (%)	6.8	N/A	Gutter 2 X Slope (%)	N/A
N/A	Painted X Walk2?	No	N/A	DWS 2 Provided?	N/A
N/A	X Walk 2 Direction	To N	N/A	DWS 2 Contrast?	N/A
N/A	X Walk 2 Width (In)	N/A	N/A	DWS 2 Length (In)	N/A
N/A	Road 2 Slope (%)	5.2	N/A	DWS 2 Full Width?	N/A

N/A	Road 2 X Slope (%)	4.0	N/A	DWS 2 Offset (In)	N/A
N/A	Refuge 3 Length (in)	N/A	N/A	Gutter 3 Ponding?	N/A
N/A	Refuge 3 Width (in)	N/A	N/A	Gutter 3 Lip Ht (in)	N/A
N/A	Refuge 3 Slope (%)	N/A	N/A	Gutter 3 Slope (%)	N/A
N/A	Refuge 3 XSlope (%)	N/A	N/A	Gutter 3 XSlope (%)	N/A
N/A	Painted X Walk3?	N/A	N/A	DWS 3 Provided?	N/A
N/A	X Walk 3 Direction	N/A	N/A	DWS 3 Contrast?	N/A
N/A	X Walk 3 Width (in)	N/A	N/A	DWS 3 Length (in)	N/A
N/A	Road 3 Slope (%)	N/A	N/A	DWS 3 Full Width?	N/A
N/A	Road 3 XSlope (%)	N/A	N/A	DWS 3 Offset (in)	N/A
Yes	Any Obstructions?	N/A	N/A	Storm Grate/Utility Hazard?	N/A
N/A	Obstruction Type		N/A	Storm Grate/Utility Type	
		N/A			N/A
N/A	Surface Condition	Good

**Remove & Replace Entire Refuge.**

**\$ 3000.00**
