Access Compliance Report

Public Rights-of-Way

(Island Curb Cuts)

Intersection ID: 14294	Main Street: EAST_BV	Cross Street: EUCLID_AV	Location: SE
ADA ID: BC76BD3ABFAD	Curb Cut Type: MedianRefuge2	Initial Pass/Fail: Pass	Overall Compliance: No
Severity Score: 0.25			
Codes/Mitigation Info/Possible Solution		Field Measurements/Component Compliance

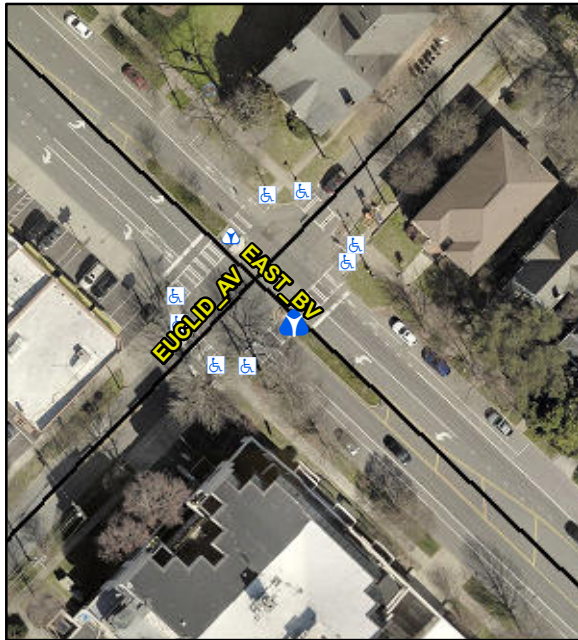
N/A	Road 2 Slope (%)	0.4	Yes	DWS 2 Full Width?	Yes
N/A	Road 2 X Slope (%)	1.0	No	DWS 2 Offset (In)	7.0
N/A	Refuge 3 Length (in)	N/A	N/A	Gutter 3 Ponding?	N/A
N/A	Refuge 3 Width (in)	N/A	N/A	Gutter 3 Lip Ht (in)	N/A
N/A	Refuge 3 Slope (%)	N/A	N/A	Gutter 3 Slope (%)	N/A
N/A	Refuge 3 XSlope (%)	N/A	N/A	Gutter 3 XSlope (%)	N/A
N/A	Painted X Walk3?	N/A	N/A	DWS 3 Provided?	N/A
N/A	X Walk 3 Direction	N/A	N/A	DWS 3 Contrast?	N/A
N/A	X Walk 3 Width (in)	N/A	N/A	DWS 3 Length (in)	N/A
N/A	Road 3 Slope (%)	N/A	N/A	DWS 3 Full Width?	N/A
N/A	Road 3 XSlope (%)	N/A	N/A	DWS 3 Offset (in)	N/A
Yes	Any Obstructions?	N/A	N/A	Storm Grate/Utility Hazard?	No
N/A	Obstruction Type		N/A	Storm Grate/Utility Type	
		N/A			N/A
N/A	Surface Condition	Good

Possible Solutions:

Remove & Replace Detectable Warning System.
