# Access Compliance Report

## Public Rights-of-Way

### (Island Curb Cuts)

Intersection ID: 15542	Main Street: CLANTON_RD	Cross Street: N_CLANTON_TO_S_I-77_RA_NB	Location: NE
ADA ID: BD7FACF17AD6	Curb Cut Type: IslandRefuge3	Initial Pass/Fail: Fail	Overall Compliance: No
Severity Score: 35			
Codes/Mitigation Info/Possible Solution		Field Measurements/Component Compliance

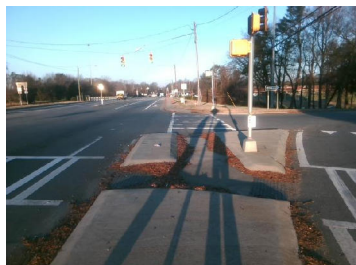
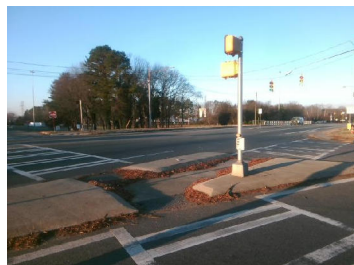
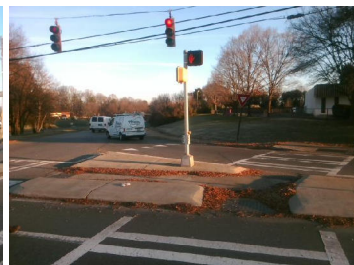
Compliance	Description	Data	Compliance	Description	Data
Yes	Refuge 1 Length (In)	32.0	N/A	Gutter 1 Ponding?	N/A
No	Refuge 1 Width (In)	59.0	N/A	Gutter 1 Lip Ht (In)	N/A
Yes	Refuge 1 Slope (%)	1.1	N/A	Gutter 1 Slope (%)	N/A
Yes	Refuge 1 X Slope (%)	3.0	N/A	Gutter 1 X Slope (%)	N/A
N/A	Painted X Walk1?	Yes	N/A	DWS 1 Provided?	N/A
N/A	X Walk 1 Direction	To NE	N/A	DWS 1 Contrast?	N/A
N/A	X Walk 1 Width (In)	111.0	N/A	DWS 1 Length (In)	N/A
N/A	Road 1 Slope (%)	1.5	N/A	DWS 1 Full Width?	N/A
N/A	Road 1 X Slope (%)	0.1	N/A	DWS 1 Offset (In)	N/A
Yes	Refuge 2 Length (In)	52.0	N/A	Gutter 2 Ponding?	N/A
Yes	Refuge 2 Width (In)	60.0	N/A	Gutter 2 Lip Ht (In)	N/A
Yes	Refuge 2 Slope (%)	1.9	N/A	Gutter 2 Slope (%)	N/A
Yes	Refuge 2 X Slope (%)	0.0	N/A	Gutter 2 X Slope (%)	N/A
N/A	Painted X Walk2?	Yes	N/A	DWS 2 Provided?	N/A
N/A	X Walk 2 Direction	To SW	N/A	DWS 2 Contrast?	N/A
N/A	X Walk 2 Width (In)	111.0	N/A	DWS 2 Length (In)	N/A

N/A	Road 2 Slope (%)	0.8	N/A	DWS 2 Full Width?	N/A
N/A	Road 2 X Slope (%)	2.9	N/A	DWS 2 Offset (In)	N/A
Yes	Refuge 3 Length (in)	187.0	N/A	Gutter 3 Ponding?	N/A
Yes	Refuge 3 Width (in)	60.0	N/A	Gutter 3 Lip Ht (in)	N/A
Yes	Refuge 3 Slope (%)	0.7	N/A	Gutter 3 Slope (%)	N/A
Yes	Refuge 3 XSlope (%)	3.8	N/A	Gutter 3 XSlope (%)	N/A
N/A	Painted X Walk3?	Yes	N/A	DWS 3 Provided?	N/A
N/A	X Walk 3 Direction	To NW	N/A	DWS 3 Contrast?	N/A
N/A	X Walk 3 Width (in)	109.0	N/A	DWS 3 Length (in)	N/A
N/A	Road 3 Slope (%)	2.2	N/A	DWS 3 Full Width?	N/A
N/A	Road 3 XSlope (%)	0.5	N/A	DWS 3 Offset (in)	N/A
Yes	Any Obstructions?	N/A	N/A	Storm Grate/Utility Hazard?	N/A
N/A	Obstruction Type		N/A	Storm Grate/Utility Type	
			N/A		N/A
N/A	Surface Condition	Good

**Remove & Replace Entire Refuge.**
