# Access Compliance Report

## Public Rights-of-Way

### (Island Curb Cuts)

Intersection ID: 11331	Main Street: E_W_T_HARRIS_BV	Cross Street: MEADOW_ROSE_LN	Location: SW
ADA ID: BE31CE4E3D5F	Curb Cut Type: MedianRefuge2	Initial Pass/Fail: Pass	Overall Compliance: Yes
Codes/Mitigation Info/Possible Solution		Field Measurements/Component Compliance	
Severity Score: 0.25

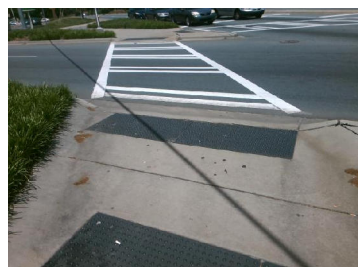
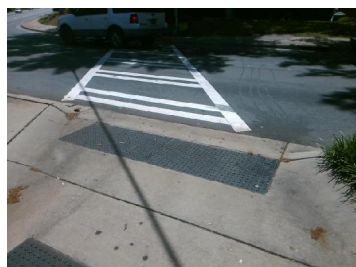
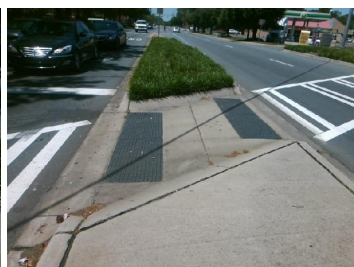
Compliance	Description	Data	Compliance	Description	Data
Yes	Refuge 1 Length (In)	56.0	Yes	Gutter 1 Ponding?	No
Yes	Refuge 1 Width (In)	112.0	Yes	Gutter 1 Lip Ht (In)	0.0
Yes	Refuge 1 Slope (%)	2.9	Yes	Gutter 1 Slope (%)	1.6
Yes	Refuge 1 X Slope (%)	1.2	Yes	Gutter 1 X Slope (%)	0.7
N/A	Painted X Walk1?	Yes	Yes	DWS 1 Provided?	Yes
N/A	X Walk 1 Direction	To NW	Yes	DWS 1 Contrast?	Yes
N/A	X Walk 1 Width (In)	113.0	Yes	DWS 1 Length (In)	24.0
N/A	Road 1 Slope (%)	0.5	Yes	DWS 1 Full Width?	Yes
N/A	Road 1 X Slope (%)	1.2	Yes	DWS 1 Offset (In)	0.0
Yes	Refuge 2 Length (In)	56.0	Yes	Gutter 2 Ponding?	No
Yes	Refuge 2 Width (In)	116.0	Yes	Gutter 2 Lip Ht (In)	0.0
Yes	Refuge 2 Slope (%)	4.9	Yes	Gutter 2 Slope (%)	3.3
Yes	Refuge 2 X Slope (%)	0.8	Yes	Gutter 2 X Slope (%)	1.4
N/A	Painted X Walk2?	Yes	Yes	DWS 2 Provided?	Yes
N/A	X Walk 2 Direction	To SE	Yes	DWS 2 Contrast?	Yes
N/A	X Walk 2 Width (In)	103.0	Yes	DWS 2 Length (In)	24.5

N/A	Road 2 Slope (%)	0.3	Yes	DWS 2 Full Width?	Yes
N/A	Road 2 X Slope (%)	2.7	Yes	DWS 2 Offset (In)	0.0
N/A	Refuge 3 Length (in)	N/A	N/A	Gutter 3 Ponding?	No
N/A	Refuge 3 Width (in)	N/A	N/A	Gutter 3 Lip Ht (in)	N/A
N/A	Refuge 3 Slope (%)	N/A	N/A	Gutter 3 Slope (%)	N/A
N/A	Refuge 3 XSlope (%)	N/A	N/A	Gutter 3 XSlope (%)	N/A
N/A	Painted X Walk3?	No	N/A	DWS 3 Provided?	N/A
N/A	X Walk 3 Direction	N/A	N/A	DWS 3 Contrast?	N/A
N/A	X Walk 3 Width (in)	N/A	N/A	DWS 3 Length (in)	N/A
N/A	Road 3 Slope (%)	N/A	N/A	DWS 3 Full Width?	N/A
N/A	Road 3 XSlope (%)	N/A	N/A	DWS 3 Offset (in)	N/A
Yes	Any Obstructions?	No	N/A	Storm Grate/Utility Hazard?	No
N/A	Obstruction Type		N/A	Storm Grate/Utility Type	
		N/A			N/A
N/A	Surface Condition	Good

N/A
