# Access Compliance Report

## Public Rights-of-Way

### (Island Curb Cuts)

Intersection ID: 11979	Main Street: N_CALDWELL_ST	Cross Street: E_12TH_ST	Location: N
ADA ID: BFDFCD1DF20A	Curb Cut Type: MedianRefuge2	Initial Pass/Fail: Fail	Overall Compliance: No
Severity Score: 1.25			
Codes/Mitigation Info/Possible Solution		Field Measurements/Component Compliance

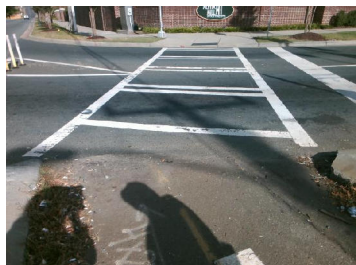
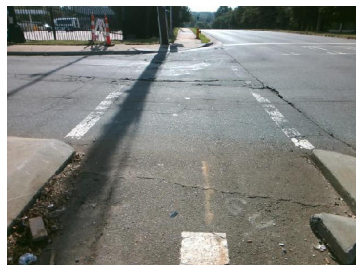
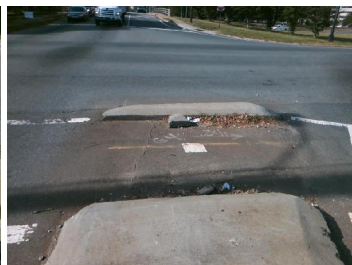
Compliance	Description	Data	Compliance	Description	Data
Yes	Refuge 1 Length (In)	45.0	N/A	Gutter 1 Ponding?	N/A
Yes	Refuge 1 Width (In)	93.5	N/A	Gutter 1 Lip Ht (In)	N/A
Yes	Refuge 1 Slope (%)	2.8	N/A	Gutter 1 Slope (%)	N/A
Yes	Refuge 1 X Slope (%)	2.3	N/A	Gutter 1 X Slope (%)	N/A
N/A	Painted X Walk1?	Yes	N/A	DWS 1 Provided?	N/A
N/A	X Walk 1 Direction	To N	N/A	DWS 1 Contrast?	N/A
N/A	X Walk 1 Width (In)	110.0	N/A	DWS 1 Length (In)	N/A
N/A	Road 1 Slope (%)	1.6	N/A	DWS 1 Full Width?	N/A
N/A	Road 1 X Slope (%)	1.7	N/A	DWS 1 Offset (In)	N/A
Yes	Refuge 2 Length (In)	45.0	N/A	Gutter 2 Ponding?	N/A
Yes	Refuge 2 Width (In)	93.5	N/A	Gutter 2 Lip Ht (In)	N/A
Yes	Refuge 2 Slope (%)	0.8	N/A	Gutter 2 Slope (%)	N/A
Yes	Refuge 2 X Slope (%)	0.7	N/A	Gutter 2 X Slope (%)	N/A
N/A	Painted X Walk2?	Yes	N/A	DWS 2 Provided?	N/A
N/A	X Walk 2 Direction	To SE	N/A	DWS 2 Contrast?	N/A
N/A	X Walk 2 Width (In)	98.0	N/A	DWS 2 Length (In)	N/A

N/A	Road 2 Slope (%)	1.7	N/A	DWS 2 Full Width?	N/A
N/A	Road 2 X Slope (%)	1.8	N/A	DWS 2 Offset (In)	N/A
N/A	Refuge 3 Length (in)	N/A	N/A	Gutter 3 Ponding?	N/A
N/A	Refuge 3 Width (in)	N/A	N/A	Gutter 3 Lip Ht (in)	N/A
N/A	Refuge 3 Slope (%)	N/A	N/A	Gutter 3 Slope (%)	N/A
N/A	Refuge 3 XSlope (%)	N/A	N/A	Gutter 3 XSlope (%)	N/A
N/A	Painted X Walk3?	N/A	N/A	DWS 3 Provided?	N/A
N/A	X Walk 3 Direction	N/A	N/A	DWS 3 Contrast?	N/A
N/A	X Walk 3 Width (in)	N/A	N/A	DWS 3 Length (in)	N/A
N/A	Road 3 Slope (%)	N/A	N/A	DWS 3 Full Width?	N/A
N/A	Road 3 XSlope (%)	N/A	N/A	DWS 3 Offset (in)	N/A
Yes	Any Obstructions?	N/A	N/A	Storm Grate/Utility Hazard?	N/A
N/A	Obstruction Type		N/A	Storm Grate/Utility Type	
		N/A			N/A
N/A	Surface Condition	Good

Possible Solutions:

**Remove & Replace Entire Refuge.**

Total Cost: \$ 3000.00
