Access Compliance Report

Public Rights-of-Way

(Island Curb Cuts)

Intersection ID: 31631	Main Street: PLAZA_WALK_DR	Cross Street: N/A	Location: N
ADA ID: C1BB82D1A854	Curb Cut Type: MedianRefuge2	Initial Pass/Fail: Fail	Overall Compliance: No
			Severity Score: 17.5

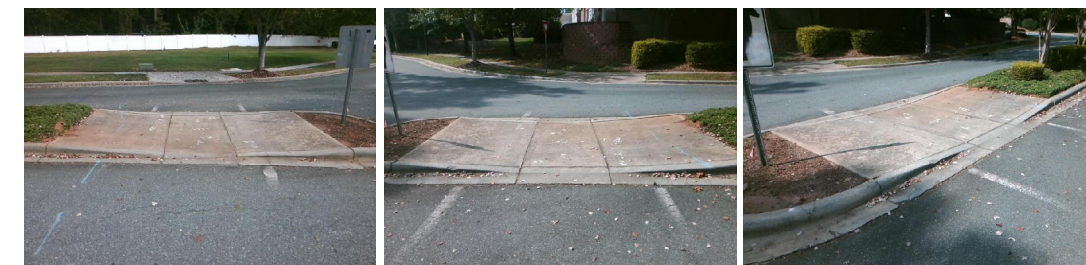
Compliance	Description	Data	Compliance	Description	Data
Yes	Refuge 1 Length (In)	47.5	N/A	Gutter 1 Ponding?	N/A
No	Refuge 1 Width (In)	47.5	N/A	Gutter 1 Lip Ht (In)	N/A
Yes	Refuge 1 Slope (%)	0.5	N/A	Gutter 1 Slope (%)	N/A
Yes	Refuge 1 X Slope (%)	2.8	N/A	Gutter 1 X Slope (%)	N/A
N/A	Painted X Walk1?	No	N/A	DWS 1 Provided?	N/A
N/A	X Walk 1 Direction	To W	N/A	DWS 1 Contrast?	N/A
N/A	X Walk 1 Width (In)	N/A	N/A	DWS 1 Length (In)	N/A
N/A	Road 1 Slope (%)	2.5	N/A	DWS 1 Full Width?	N/A
N/A	Road 1 X Slope (%)	1.5	N/A	DWS 1 Offset (In)	N/A
Yes	Refuge 2 Length (In)	47.5	N/A	Gutter 2 Ponding?	N/A
No	Refuge 2 Width (In)	47.5	N/A	Gutter 2 Lip Ht (In)	N/A
Yes	Refuge 2 Slope (%)	0.8	N/A	Gutter 2 Slope (%)	N/A
Yes	Refuge 2 X Slope (%)	2.4	N/A	Gutter 2 X Slope (%)	N/A
N/A	Painted X Walk2?	No	N/A	DWS 2 Provided?	N/A
N/A	X Walk 2 Direction	To E	N/A	DWS 2 Contrast?	N/A
N/A	X Walk 2 Width (In)	N/A	N/A	DWS 2 Length (In)	N/A

N/A	Road 2 Slope (%)	1.9	N/A	DWS 2 Full Width?	N/A
N/A	Road 2 X Slope (%)	0.8	N/A	DWS 2 Offset (In)	N/A
N/A	Refuge 3 Length (in)	N/A	N/A	Gutter 3 Ponding?	N/A
N/A	Refuge 3 Width (in)	N/A	N/A	Gutter 3 Lip Ht (in)	N/A
N/A	Refuge 3 Slope (%)	N/A	N/A	Gutter 3 Slope (%)	N/A
N/A	Refuge 3 XSlope (%)	N/A	N/A	Gutter 3 XSlope (%)	N/A
N/A	Painted X Walk3?	N/A	N/A	DWS 3 Provided?	N/A
N/A	X Walk 3 Direction	N/A	N/A	DWS 3 Contrast?	N/A
N/A	X Walk 3 Width (in)	N/A	N/A	DWS 3 Length (in)	N/A
N/A	Road 3 Slope (%)	N/A	N/A	DWS 3 Full Width?	N/A
N/A	Road 3 XSlope (%)	N/A	N/A	DWS 3 Offset (in)	N/A
Yes	Any Obstructions?	N/A	N/A	Storm Grate/Utility Hazard?	N/A
N/A	Obstruction Type		N/A	Storm Grate/Utility Type	
		N/A			N/A
N/A	Surface Condition	Good

Remove & Replace Entire Refuge.
