Access Compliance Report

Public Rights-of-Way

(Island Curb Cuts)

Intersection ID: 16248	Main Street: OAK_LAKE_BV	Cross Street: YORKMONT_RD	Location: E
ADA ID: C1FEFE201145	Curb Cut Type: MedianRefuge2	Initial Pass/Fail: Fail	Overall Compliance: No
Severity Score: 0			
Codes/Mitigation Info/Possible Solution		Field Measurements/Component Compliance

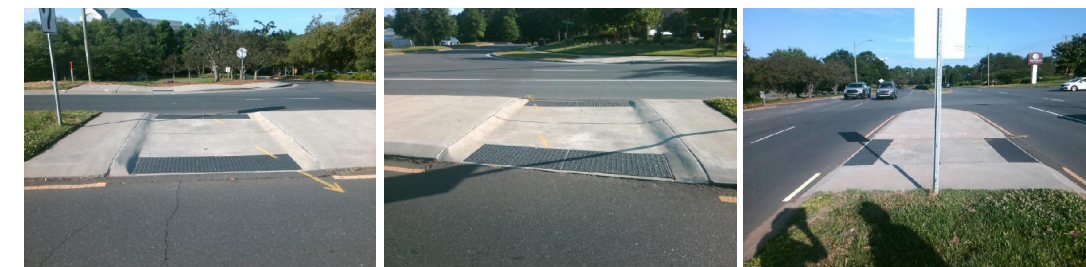
Compliance	Description	Data	Compliance	Description	Data
Yes	Refuge 1 Length (In)	79.0	N/A	Gutter 1 Ponding?	N/A
Yes	Refuge 1 Width (In)	100.0	N/A	Gutter 1 Lip Ht (In)	N/A
Yes	Refuge 1 Slope (%)	1.9	N/A	Gutter 1 Slope (%)	N/A
Yes	Refuge 1 X Slope (%)	2.9	N/A	Gutter 1 X Slope (%)	N/A
N/A	Painted X Walk1?	No	N/A	DWS 1 Provided?	N/A
N/A	X Walk 1 Direction	To S	N/A	DWS 1 Contrast?	N/A
N/A	X Walk 1 Width (In)	N/A	N/A	DWS 1 Length (In)	N/A
N/A	Road 1 Slope (%)	2.3	N/A	DWS 1 Full Width?	N/A
N/A	Road 1 X Slope (%)	0.5	N/A	DWS 1 Offset (In)	N/A
Yes	Refuge 2 Length (In)	79.0	N/A	Gutter 2 Ponding?	N/A
Yes	Refuge 2 Width (In)	100.0	N/A	Gutter 2 Lip Ht (In)	N/A
Yes	Refuge 2 Slope (%)	1.4	N/A	Gutter 2 Slope (%)	N/A
Yes	Refuge 2 X Slope (%)	4.3	N/A	Gutter 2 X Slope (%)	N/A
N/A	Painted X Walk2?	No	N/A	DWS 2 Provided?	N/A
N/A	X Walk 2 Direction	To N	N/A	DWS 2 Contrast?	N/A
N/A	X Walk 2 Width (In)	N/A	N/A	DWS 2 Length (In)	N/A

N/A	Road 2 Slope (%)	2.8	N/A	DWS 2 Full Width?	N/A
N/A	Road 2 X Slope (%)	4.7	N/A	DWS 2 Offset (In)	N/A
N/A	Refuge 3 Length (in)	N/A	N/A	Gutter 3 Ponding?	N/A
N/A	Refuge 3 Width (in)	N/A	N/A	Gutter 3 Lip Ht (in)	N/A
N/A	Refuge 3 Slope (%)	N/A	N/A	Gutter 3 Slope (%)	N/A
N/A	Refuge 3 XSlope (%)	N/A	N/A	Gutter 3 XSlope (%)	N/A
N/A	Painted X Walk3?	N/A	N/A	DWS 3 Provided?	N/A
N/A	X Walk 3 Direction	N/A	N/A	DWS 3 Contrast?	N/A
N/A	X Walk 3 Width (in)	N/A	N/A	DWS 3 Length (in)	N/A
N/A	Road 3 Slope (%)	N/A	N/A	DWS 3 Full Width?	N/A
N/A	Road 3 XSlope (%)	N/A	N/A	DWS 3 Offset (in)	N/A
Yes	Any Obstructions?	N/A	N/A	Storm Grate/Utility Hazard?	N/A
N/A	Obstruction Type		N/A	Storm Grate/Utility Type	
		N/A			N/A
N/A	Surface Condition	Good

Possible Solutions:

Remove & Replace Entire Refuge.
